The Architecture
of Arroyo Hondo Pueblo,
New Mexico

WINIFRED CREAMER

ARROYO HONDO ARCHAEOLOGICAL SERIES, VOLUME 7

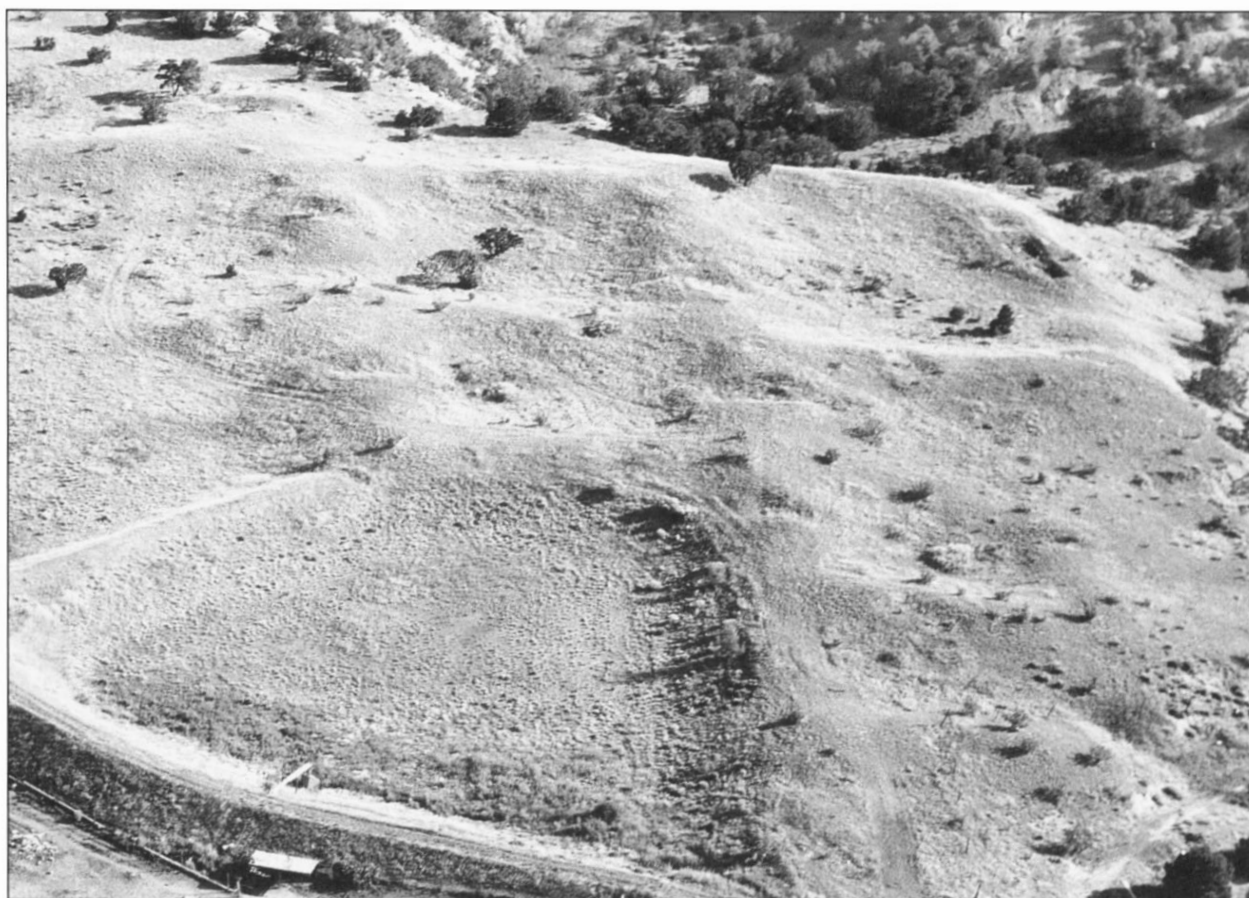
Figure 1.3. Arroyo Hondo before excavation. The D-shaped depression in the foreground is a modern stock tank. The arroyo is in the upper part of the photo, with the spring at the very right edge of the photo.

Before excavation, Arroyo Hondo appeared as a geometric series of gently rounded earthen ridges (fig. 1.3). Weathering had reduced most walls to less than half their original height, although in some places, coursed adobe walls still stood as high as 2.8 m. At the height of its occupation, the pueblo was a long, low set of interconnected structures. The village covered 6 acres and included 24 terraced, one- and two-story roomblocks arranged to enclose or partially enclose 13 rectilinear plazas (figs. 1.4, 1.5). Laid out along north-south and

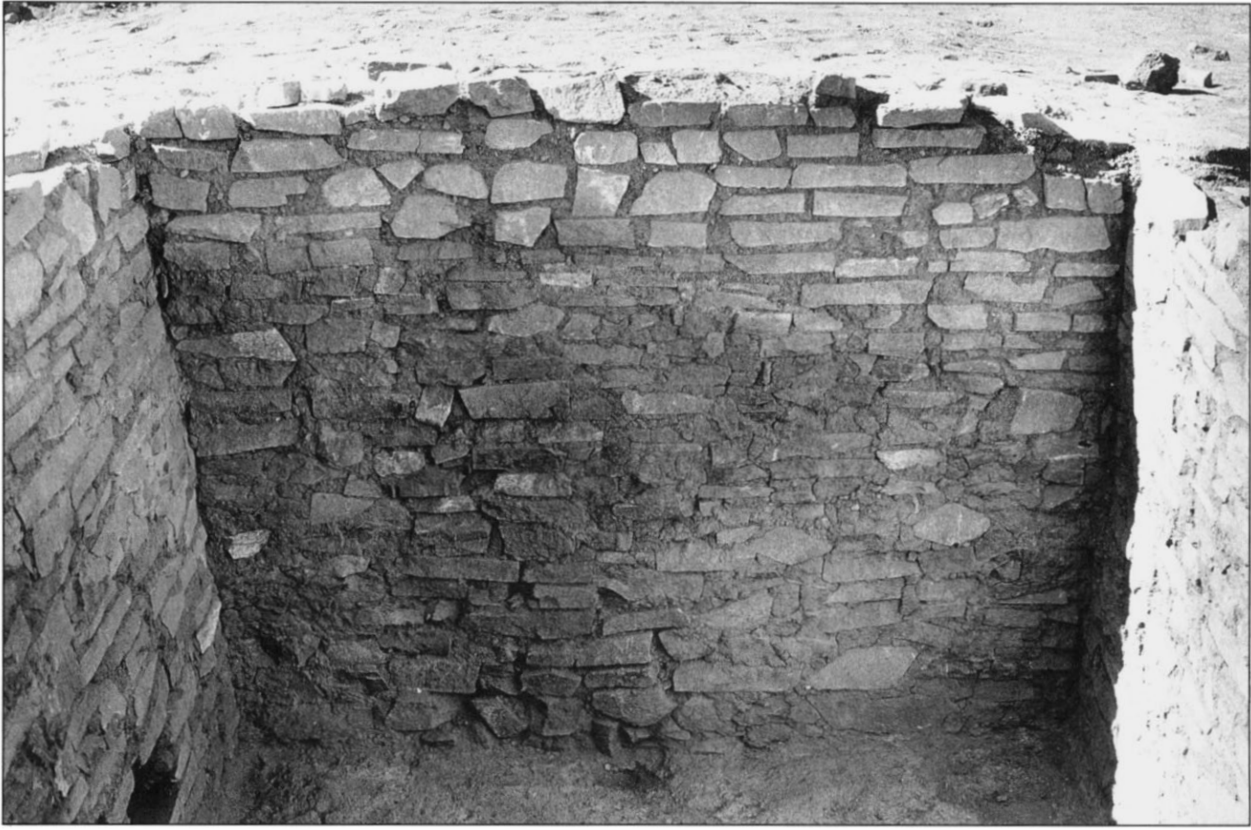
Figure 2.3. Stone masonry wall, the south wall of room 11-4. Only a few of the rooms at Arroyo Hondo were built of masonry, and they were apparently the first built at the site. (Photo AH1-JDB2).

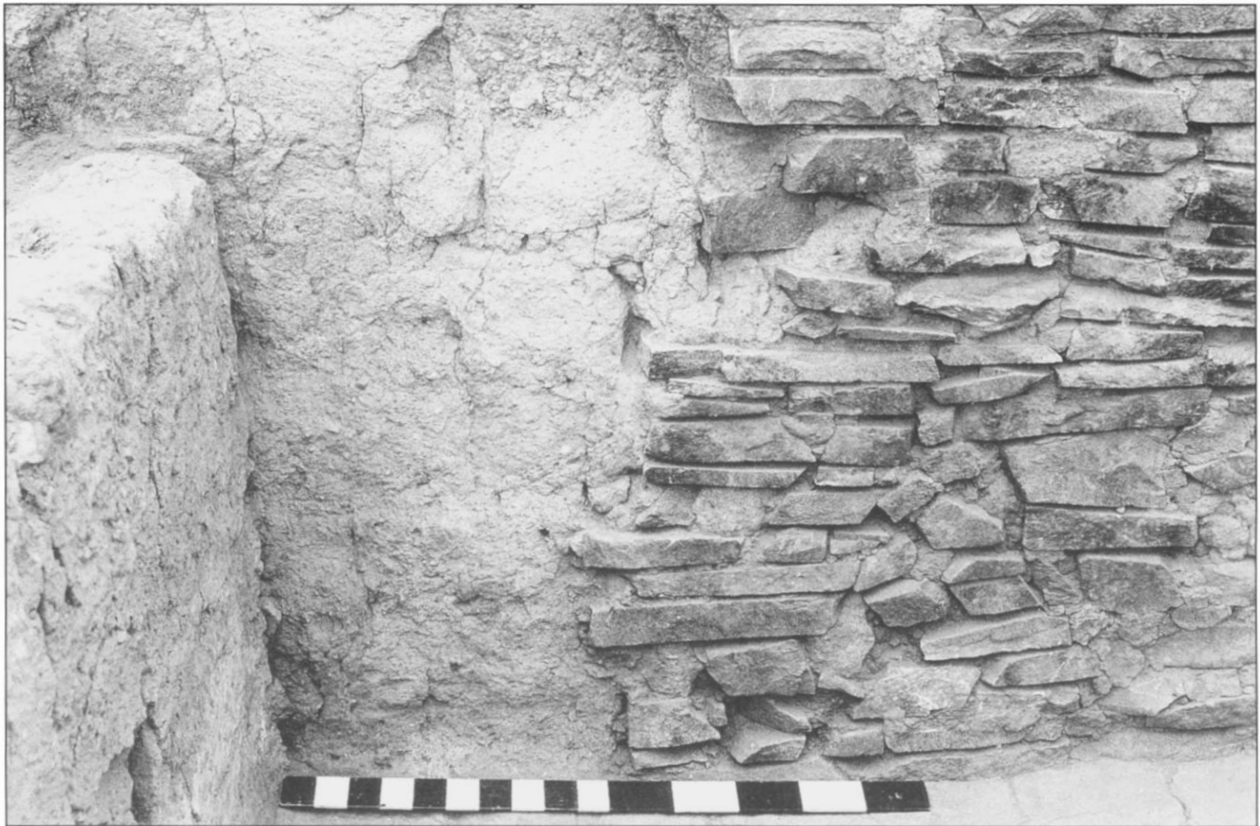
Figure 2.4. Adobe and masonry wall abutment in room 11-5. The first few rooms built at Arroyo Hondo were masonry, but the bulk of the pueblo was built of adobe. This room illustrates the shift from masonry to adobe construction in a single wall. (Photo AH1-JDB4).

Within a short time, builders at Arroyo Hondo began to use both stone and adobe. The shift from stone masonry to coursed adobe appears in the west wall of room 11-5 (fig. 2.4), and in room 6-6. Apparently, only enough stone was available to build portions of these

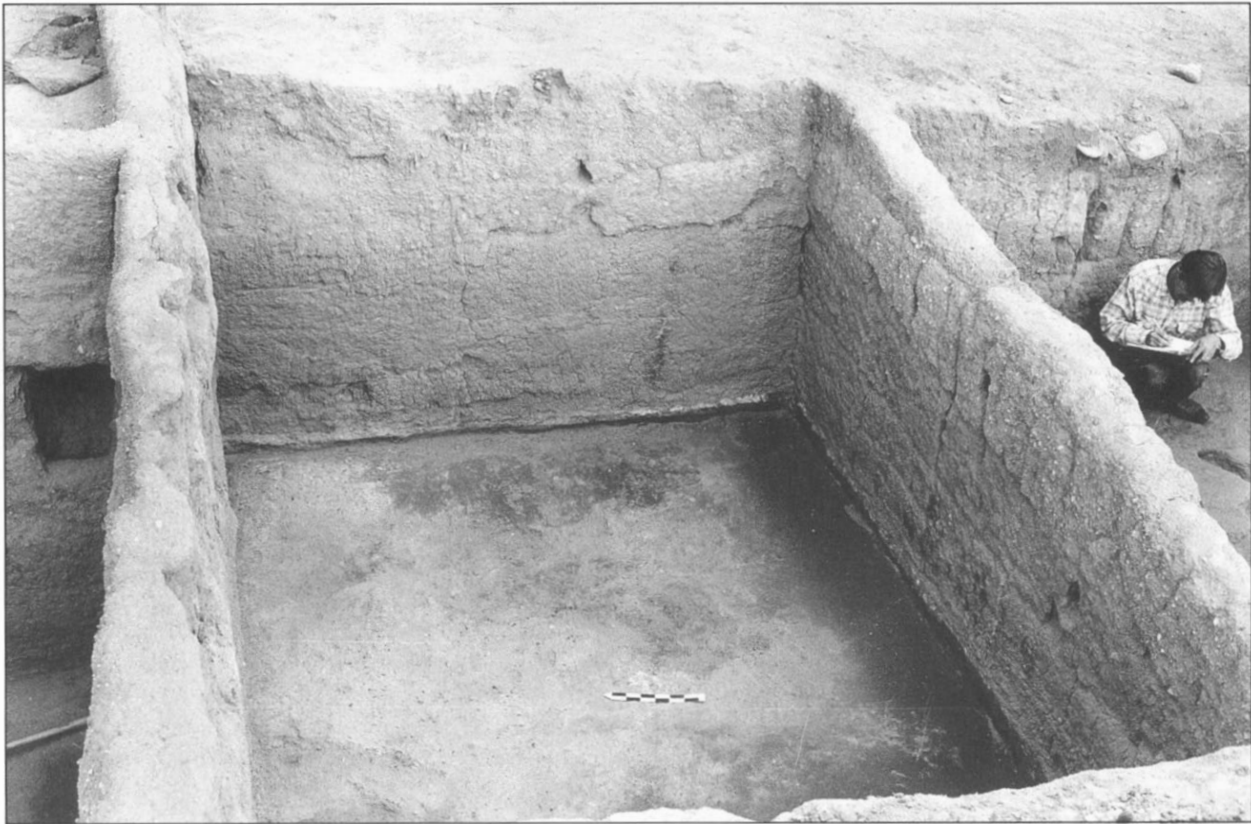
Figure 2.5. Adobe walls in room 16-33. Note striations and changes in texture indicating courses. Crew chief Richard Lang is taking notes in the adjacent room. (Photo AH1-RWL11).

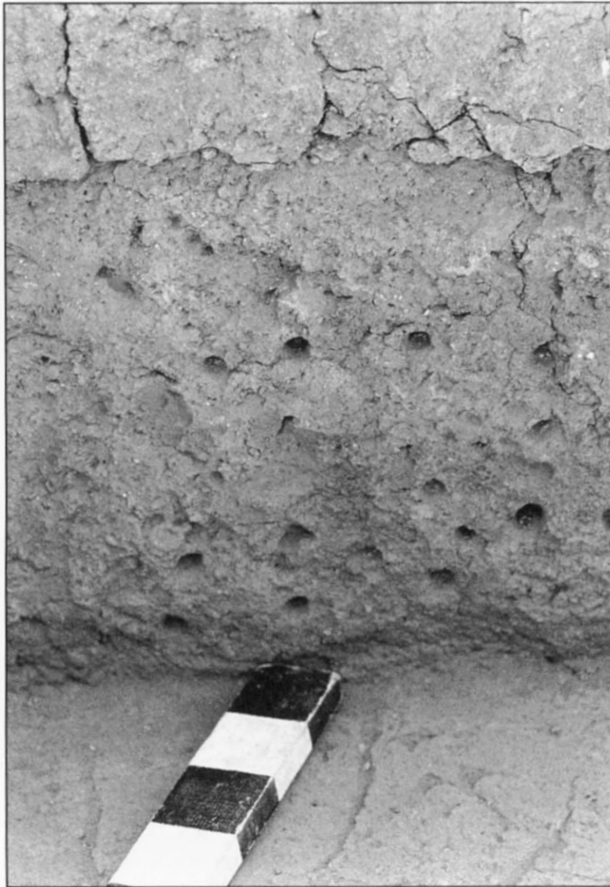
Figure 2.6. Close-up of finger impressions in the wall of room 14.5. Scale indicates 5 cm increments.

the depressions were patterned in four horizontal rows, with twelve indentations per row. This panel was located 80 cm above the floor and encompassed an area of the wall surface measuring 16 by 40 cm. Another example in room 14-5 exhibited eighteen depressions in the first course of the adobe wall (fig. 2.6); however, no definite repetitive pattern was evident. The topmost depressions were aligned in a row of five; the others occurred at random. This cluster covers a wall area measuring 25 by 32 cm. Two other rooms produced similar features, and one set of depressions was identified on a fallen block of wall rubble from a second-story room. The function of finger impressions, if any, is uncertain.

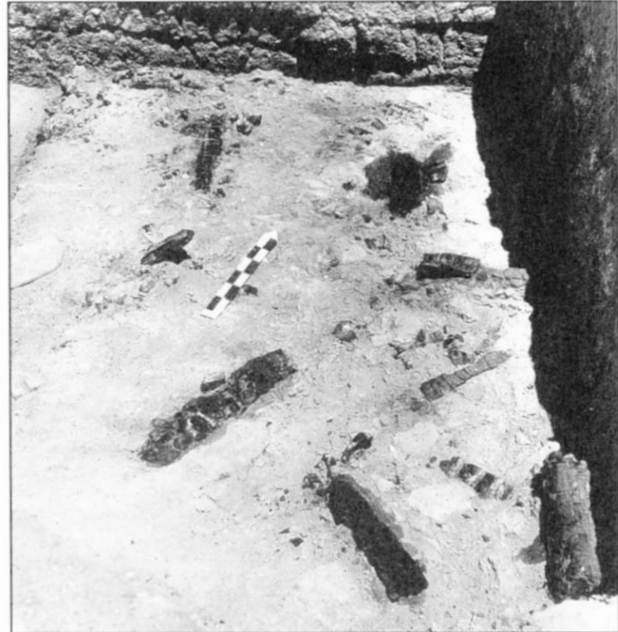
Figure 2.7. Portions of burned beams from the fallen first-story roof in room 5-6. The photo shows only some of the burned roof beams; others were removed during excavation. The room burned before abandonment. (Photo AH2-MM11).

None of the structures excavated possessed an intact roof, though impressed adobe, timbers, and brush—all used in roofing—were recovered from stratified deposits (fig. 2.7). Vigas, the main support members for pueblo roofs, were set across the short axis of the rooms. Measurable heights of beams above the finished floor level

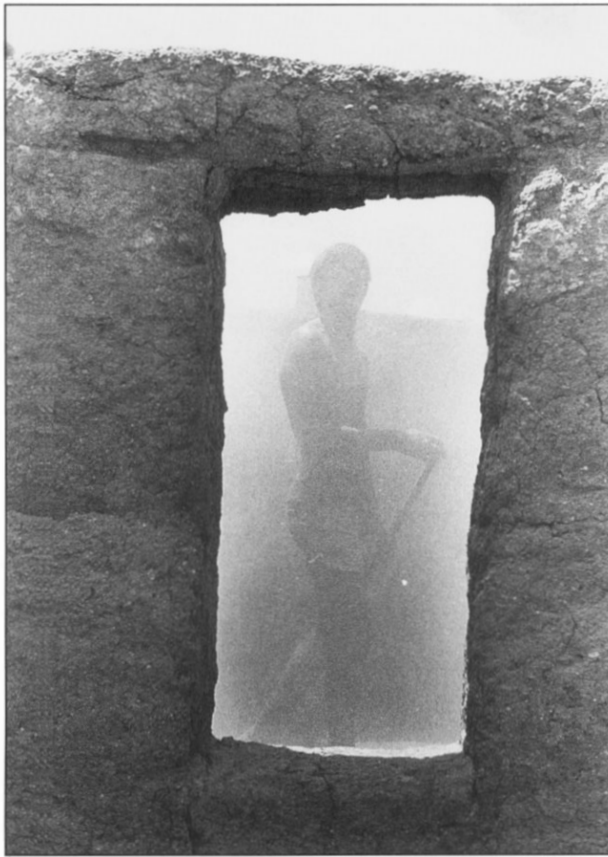
Figure 2.8. Unblocked doorway in east wall of room 18-42 with crew member Greg Stark in the room beyond. (Photo AH3-MM7).

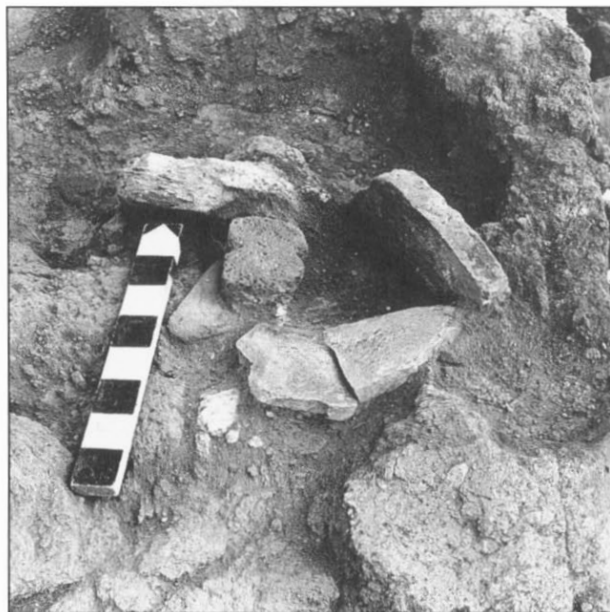
Figure 2.13. Slab-lined hearth fallen from second-story roof of room 24-3. Scale is 40 cm in 5 cm increments. (Photo AH2-MM1).

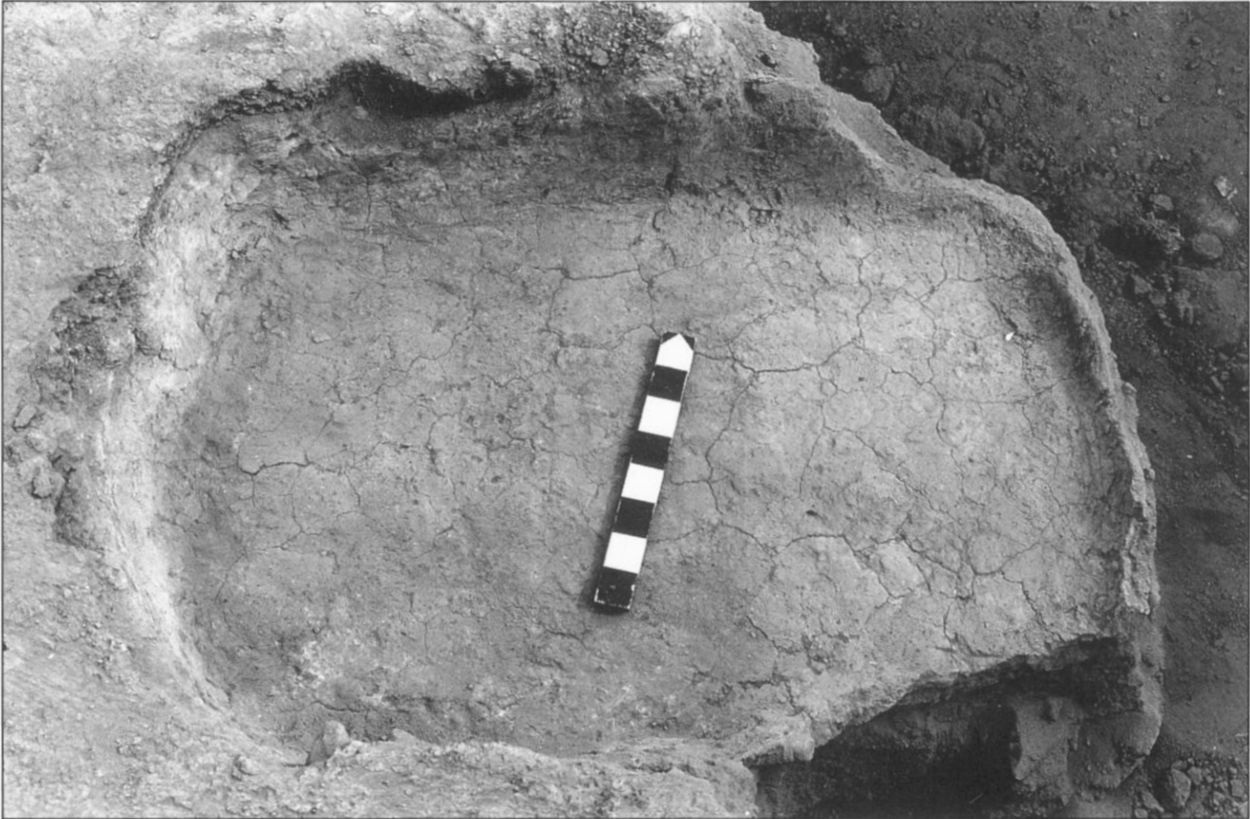
Figure 2.14. Cists of a variety of sizes and shapes were found on room floors. This large, shallow cist is in room 10-3; similar cists were also found in plaza areas. Scale is 40 cm in 5 cm increments. Figures 2.15 through 2.17 show subfloor room cists of different shapes and sizes. The function of these cists is uncertain. (Photo AH2-JDB7).

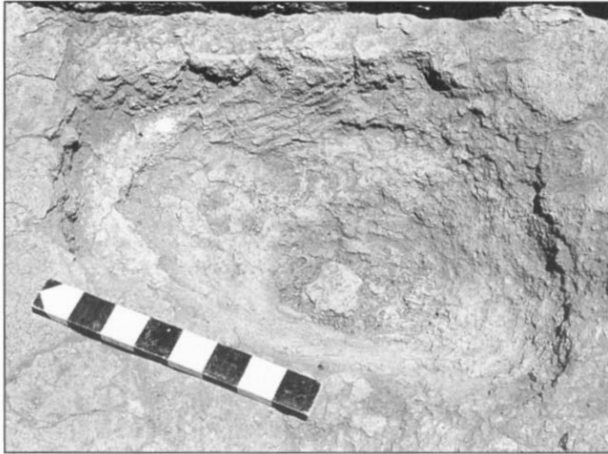
Figure 2.15. Deep, ovoid cist in room 24-3. Scale is 40 cm in 5 cm increments. (Photo AH2-MM1).

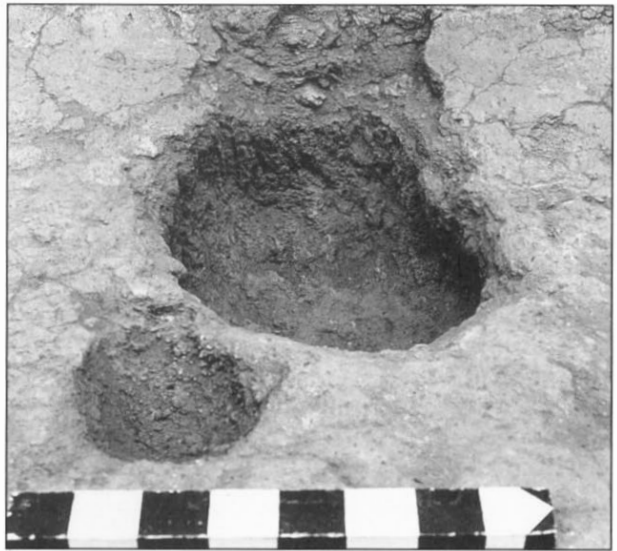
Figure 2.17. Subfloor cists along the south wall of room 5-4. Scale is 40 cm in 5 cm increments. (Photo AH2-JDB5).

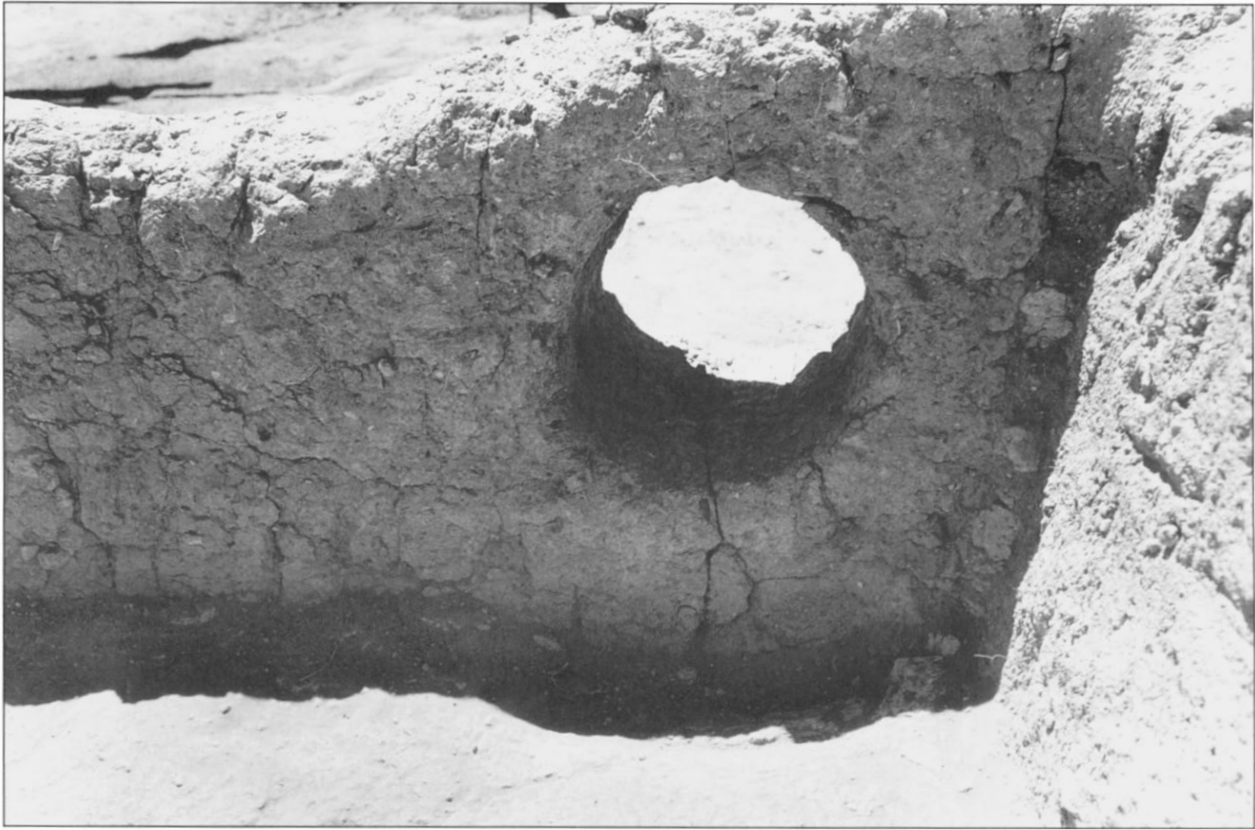
Figure 2.18. Vent in west wall of room 3-13. Vents in walls may have circulated fresh air, directed smoke from interior hearths, and been used as a means of communication between rooms. (Photo AH4-DGN7-14).

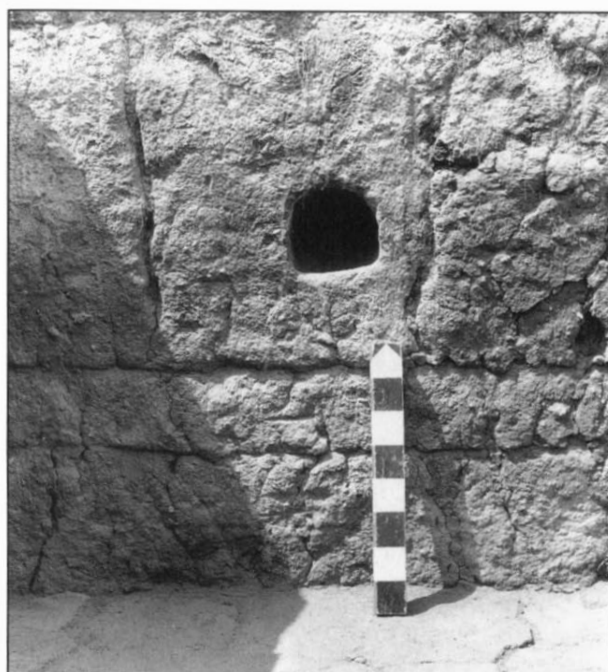
Figure 2.19. Wall niche in the north wall of room 5-6. Scale is 40 cm in 5 cm increments. (Photo AH2-MM13-4).

Small rectangular or cylindrical holes penetrating into but not through walls were called “wall niches.” Of the seven niches recorded, all but one appear to have been planned features fashioned as the walls of a room were erected (table 2.10; fig. 2.19). Five rooms had only one niche; room 11-9 had two niches. Five niches were at least fifty centimeters above the floor of the room. Openings measured 7 to 28 cm deep. Three niches were sealed with adobe: two permanently and one with a removable plug. These features may have provided storage space for small or prized items. Similar features were recorded in two kivas at Arroyo Hondo (12-G-5, 12-14-6). No niches were found in second-story rooms, probably because second-story walls were so poorly preserved.

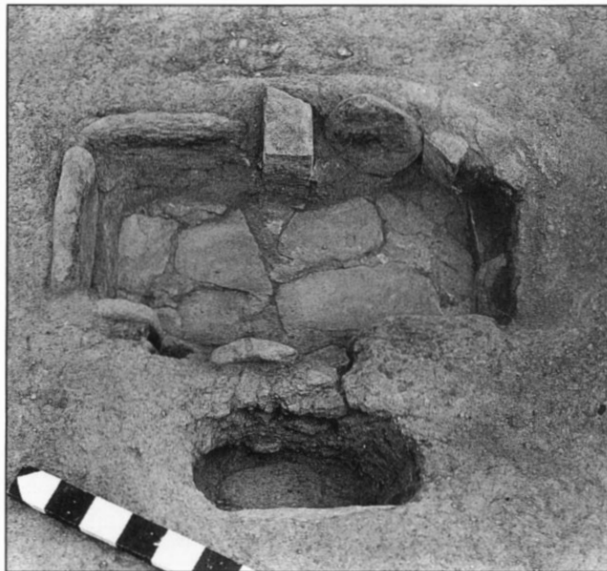
Figure 3.4. Slab-lined hearth and adjacent ashpit in room 8-6. Slab-lined hearths were the most common hearth type during Component II. Scale is 40 cm in 5 cm increments. (Photo AH3-RWL9).

Hearths within rooms were usually placed along a long-axis wall near its center. Similarly, at Unshagi, most hearths were located along the walls, with some apparent preference for the east wall of the room (Reiter 1938:49). In contrast, Component I hearths were located primarily in the center of the room (chapter 2). At Pueblo del Encierro, rectangular hearths were the most common type, but the frequency of hearths was much greater than it was at Component II Arroyo Hondo and apparently at other sites (Snow 1976:A5). Many excavated rooms had multiple hearths, which may indicate a longer occupation of individual rooms at Pueblo del Encierro than at Arroyo Hondo, as was noted above in the discussion of multiple floors at these sites.

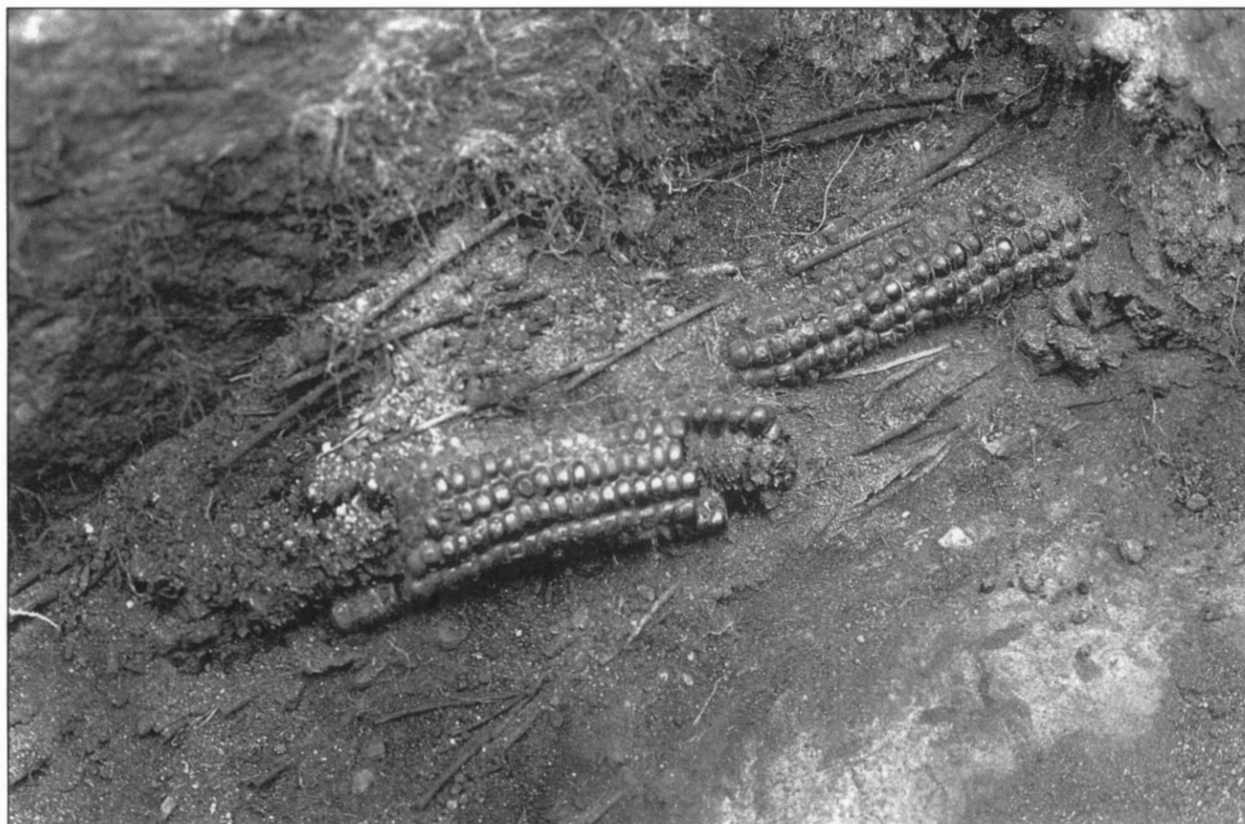
Figure 3.5. Corncobs being excavated in room 9-6. This room burned with a rack of stored corn in place. (Photo AH2-DGN25-35).

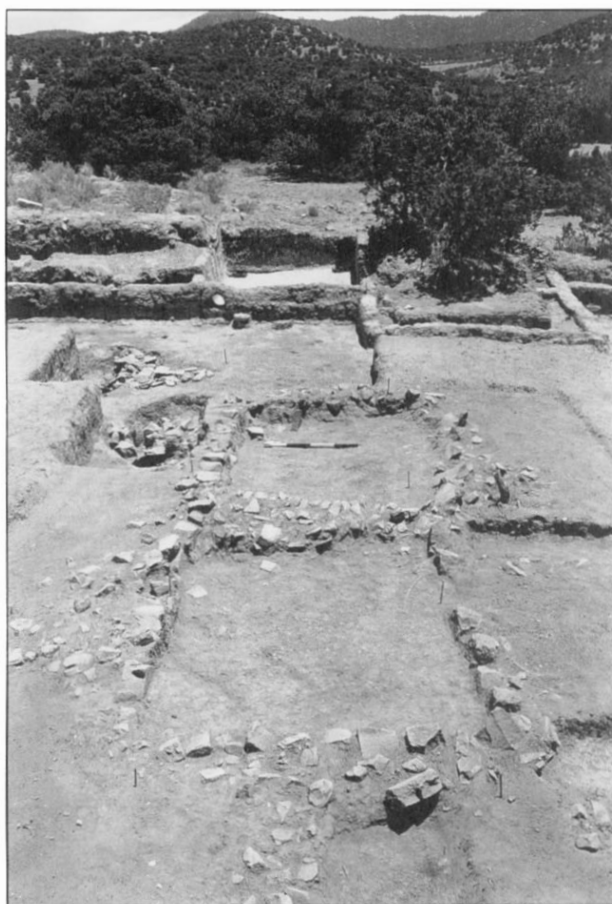
Figure 4.3. Plaza A, looking east, showing the masonry rooms in the foreground (features E and F). Scale is 1 m in 25 cm increments. (Photo AH4-MM4-11).

Test trench A-1 was excavated in plaza A in 1971. Excavation of the east half of plaza A was undertaken in 1974. In total, more than 8% (40 m²) of the 475 m² of plaza A was excavated (figs. 4.2, 4.3). The upper plaza surface was located about fifty centimeters below the ground surface (table 4.2). Features recorded in this hard-packed surface included a borrow pit, a midden-filled basin, and adjoining masonry rooms (table 4.3). The masonry structures are unique at the site (see description below). No tree-ring dates are associated with the upper surface, which contained about half as much midden as the lower plaza surface. It seems likely that this surface is associated with the construction and use of the outer rows of rooms in roomblocks 1, 2 and 3, and that it was occupied at the end of the Component I occupation. However, since the masonry rooms are stratigraphically higher than a feature dated at A.D. 1329 (see below), it is possible that the upper surface features are associated with seasonal use of roomblocks 1, 2, and 3 between about A.D. 1340 and 1360, a period in which Arroyo Hondo was sparsely occupied or for the most part abandoned.

Two rooms built in plaza A out of mud and stone appear to have been shelters or storage areas (table 4.3; figs. 4.2 and 4.3). Both rooms were built at the same time, facing south, with standing walls 20 to 35 cm high and 35 to 60 cm wide. Large tabular slabs and blocks were used for the lowest courses of the structures; upper courses were made of small angular stones set in adobe mortar. Rubble from collapsed walls formed a low mound over the structures. A door 55 cm wide in the westernmost room was the only entry identified. No interior features were encountered during excavation. Roofing materials and stratified deposits other than wall rubble were absent.

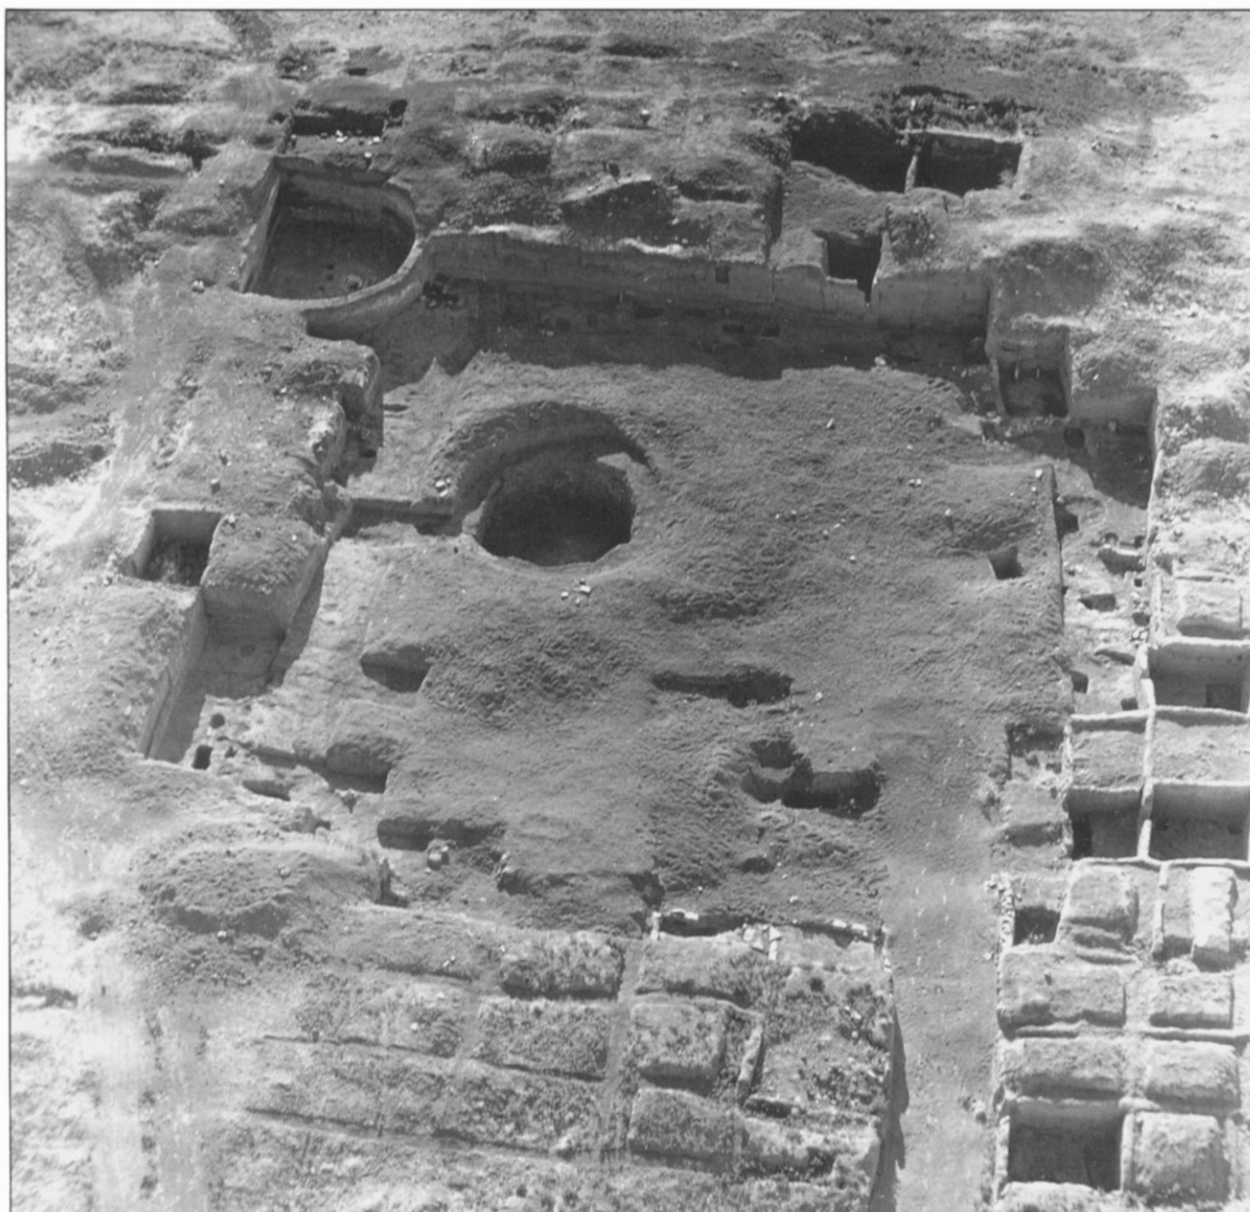
Figure 4.5. Aerial view of plaza G. Kiva G is in the center of plaza G and D-shaped kiva 14-6 can be seen at the top left. (Photo AH4-DGN40-12).

Excavations in plaza G were extensive, encompassing more than 46% (310 m²) of the 672 m² of enclosed area (figs. 4.4, 4.5). Plaza G has one definite plaza surface, in addition to more ephemeral upper and lower use surfaces (table 4.4). The uppermost excavated layer was primarily overburden of trash, adobe from collapsed surrounding structures, and sand blown in after the plaza

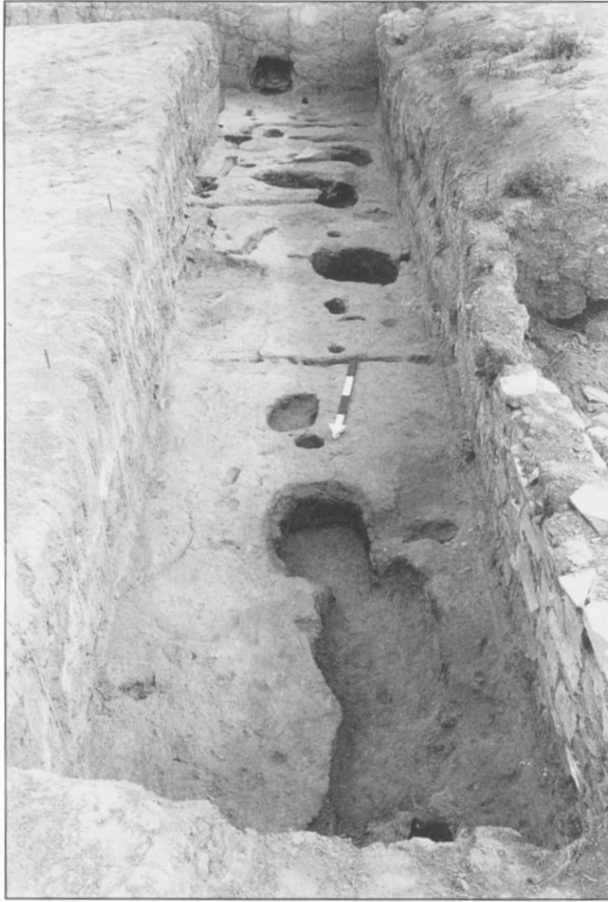
Figure 4.7. Overview of plaza K from the north along the west wall of roomblock 6. The numerous excavated features show the variety of domestic activities that took place on the plaza. Scale is 1 m in 25 cm increments. (Photo AH4-DCN63-25).

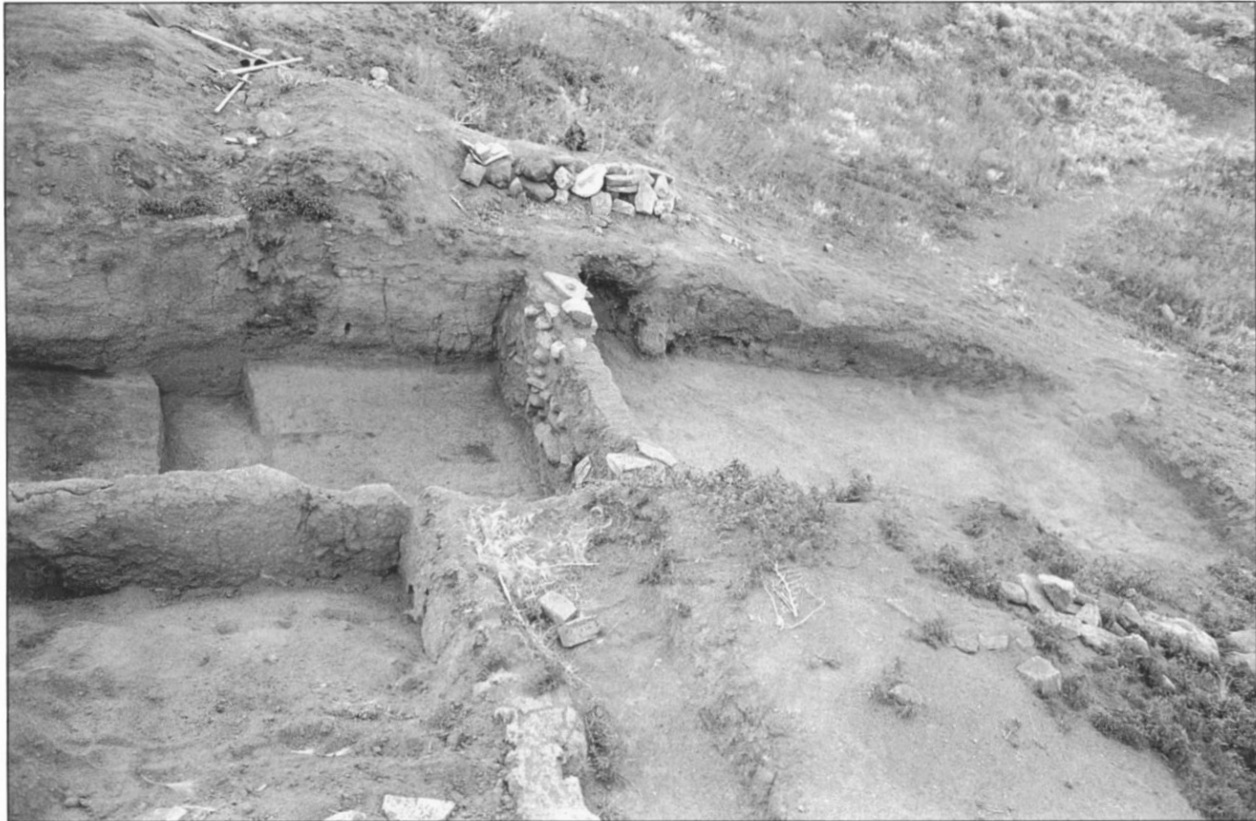
Figure 4.8. Gateway to plaza G (center of photo). The wall across the gateway was added late in the use of plaza G, perhaps to pen turkeys that were allowed to run free in the plaza. (Photo AH3-JDB3-9).

way. Later, a masonry wall was erected across the entrance and may have kept in turkeys that were allowed free run in the abandoned plaza (fig. 4.8). Similar blocking of the gateways was not observed in the other passages tested.

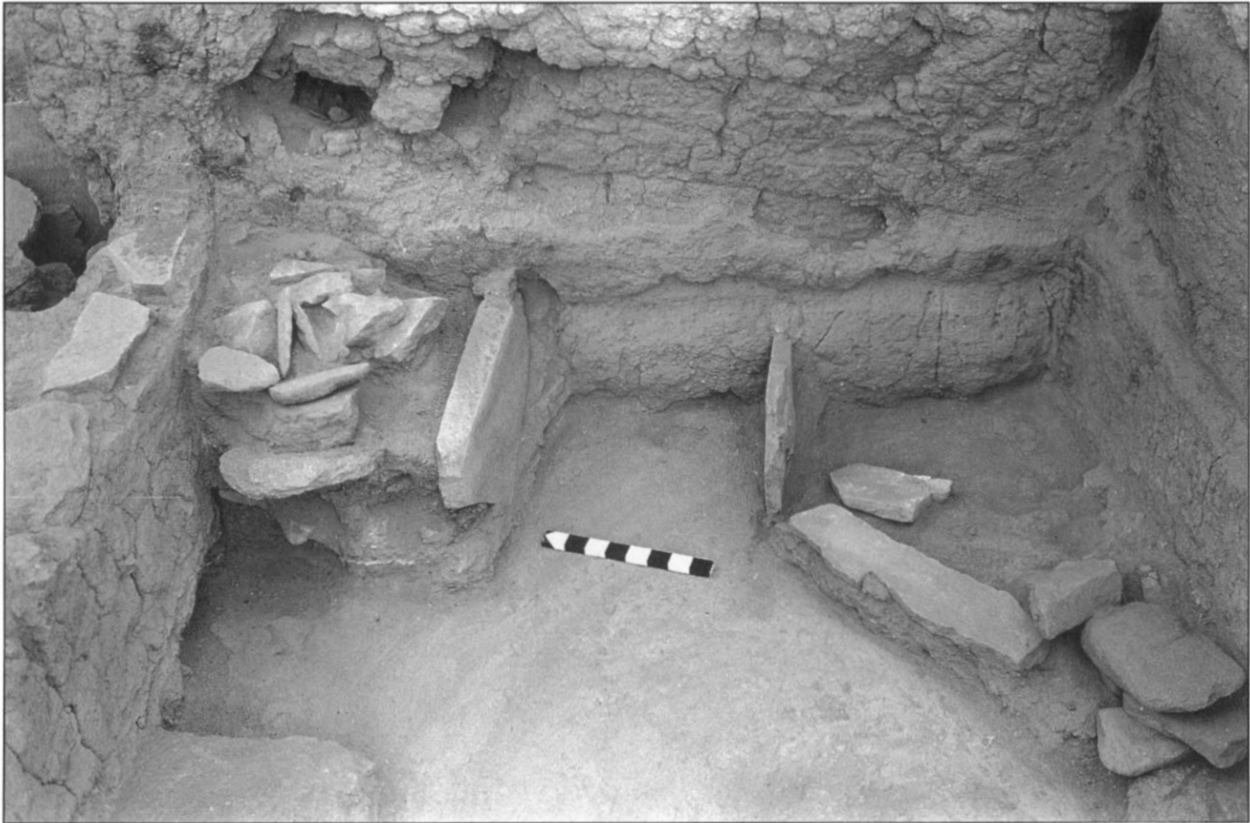
Figure 4.9. Mealing bin (above scale) in plaza G. Scale is 40 cm in 5 cm increments. (Photo AH3-JDB7-3).

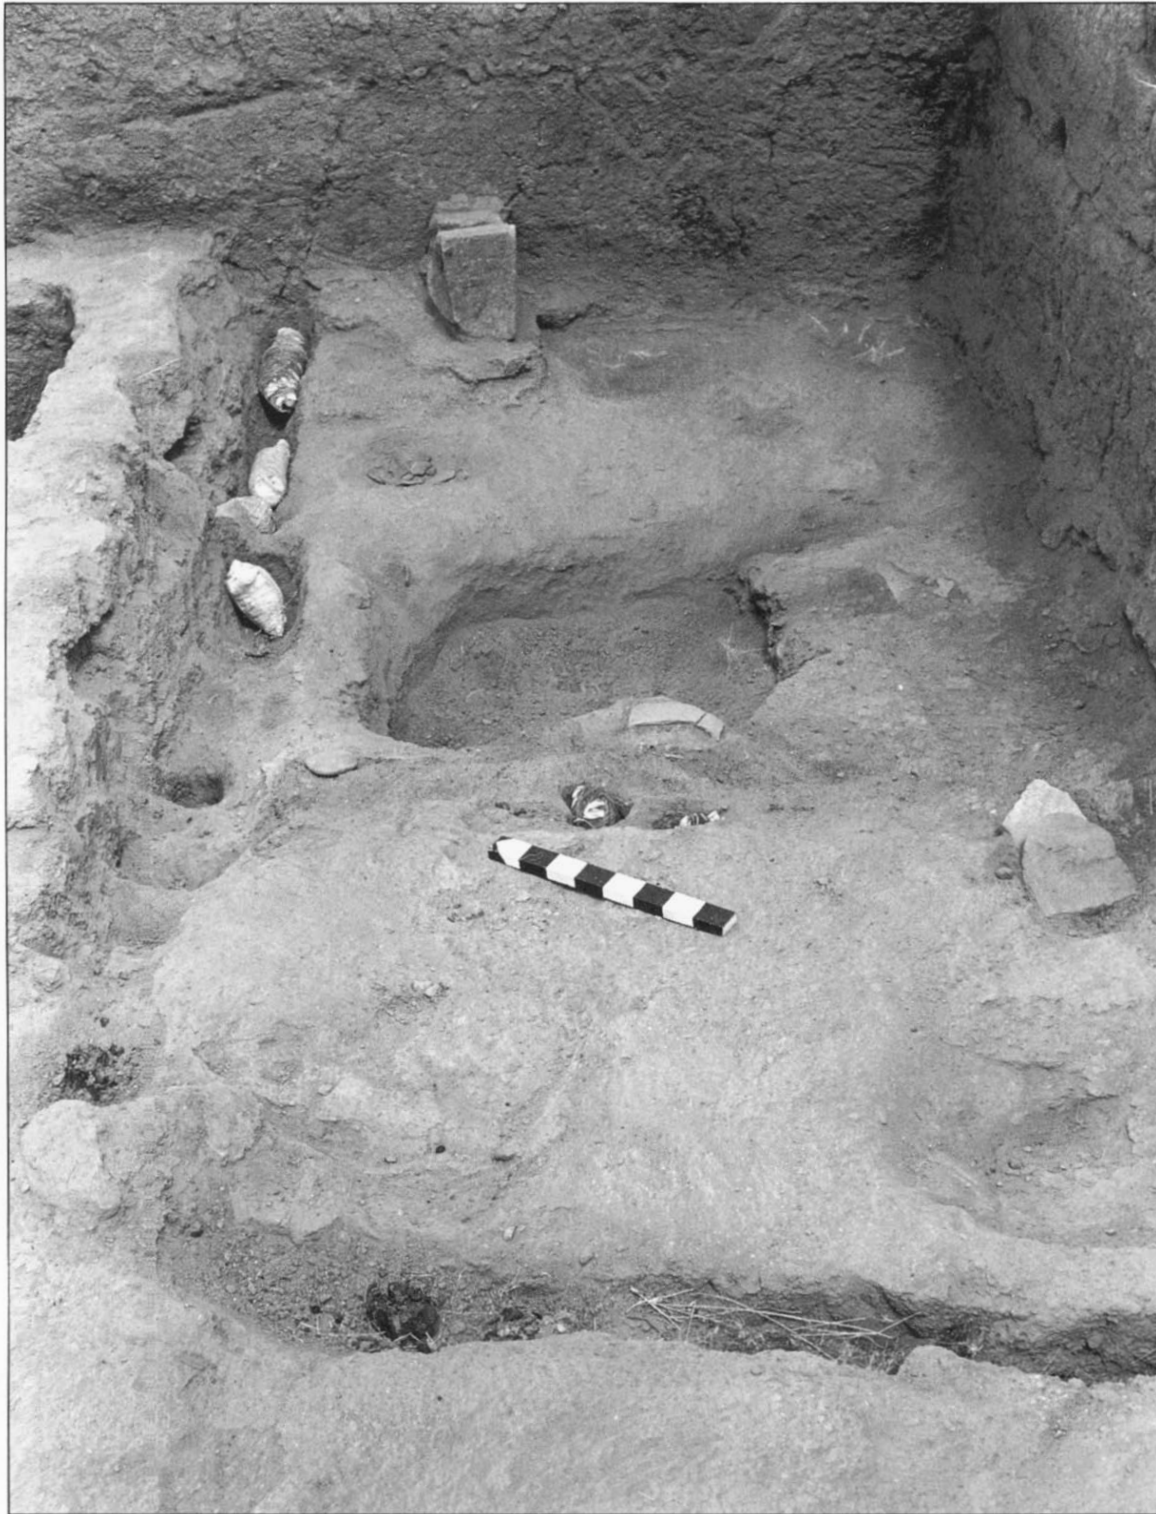
Figure 4.10. The narrow trench bounding this corner of plaza G was the foundation for a post and brush turkey pen (Feature G-2-3-24). The remains of the posts (some wrapped for dendrochronological analysis) can be seen in the trench. The pen was filled with stratified eggshell and turkey dung. Food and water vessels and a horizontal roost were found inside. (Photo AH3-JDB6-5).

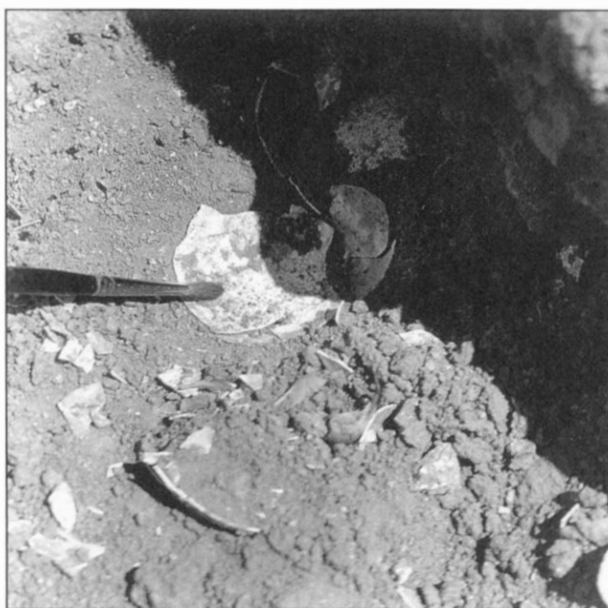
Figure 4.11. Excavation of turkey eggs from plaza K. Several turkey pens were located in plaza K. (Photo AH4-DGN51-9).

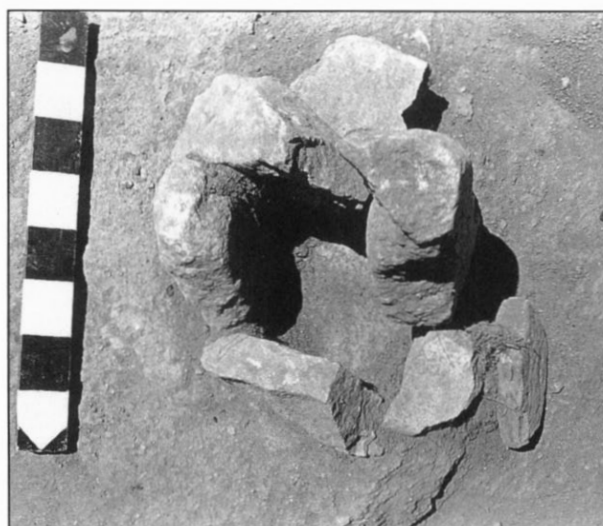
Figure 4.12. Post support for portal in plaza G. Scale is 40 cm in 5 cm increments. (Photo AH4-JDB2-15).

G-C38-112, 12-K-13-8; figs. 4.4 and 4.6). Stone slabs were set at the bottom of many of the post holes as footings, and stones were used as wedges to stabilize the posts (fig. 4.12). Several deeply set posts (for example, feature 12-K-3-13) may also have supported ramadas, though most post holes ranged from 25 to 35 cm deep. No evidence of roofing materials, such as adobe impressions or wood, was recovered, which suggests that brush was used as roof covering. The large number of post holes in plaza areas made it difficult to identify individual ramadas or *portales*.

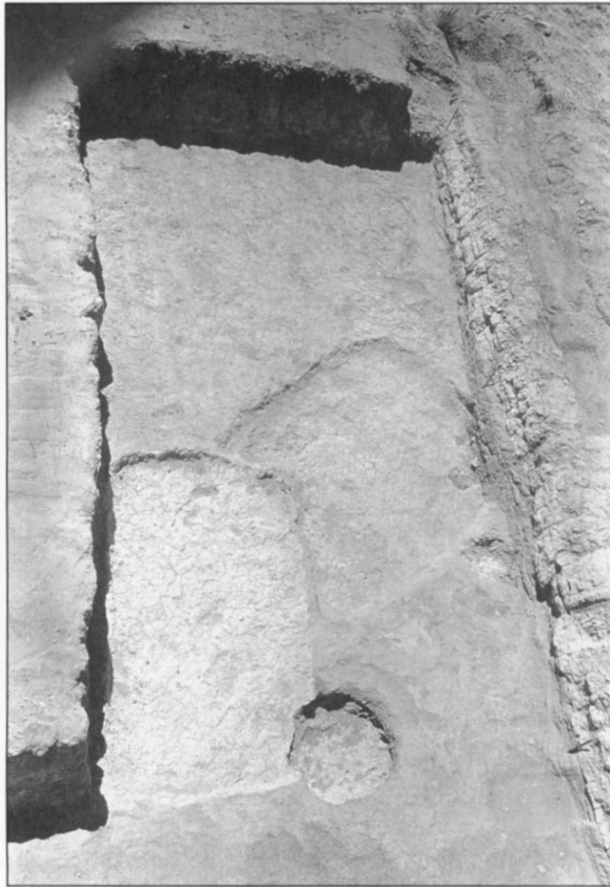
Figure 4.13. The two large, shallow basins located in plaza A (features A and C), visible in the center of the photo, were suggested to be winnowing basins based on pollen analysis of their contents. The small round cist adjacent to the basins was of undetermined function. Another small cist, found above basin C, was removed when basin C was excavated. (Photo AH4-MPM3-31).

Four shallow, subrectangular basins were found in plazas A and K (A-1-A, A-2-C, A-1-I, and K-14-4); none were found in plaza G (figs. 4.2, 4.13). Each basin was plas-

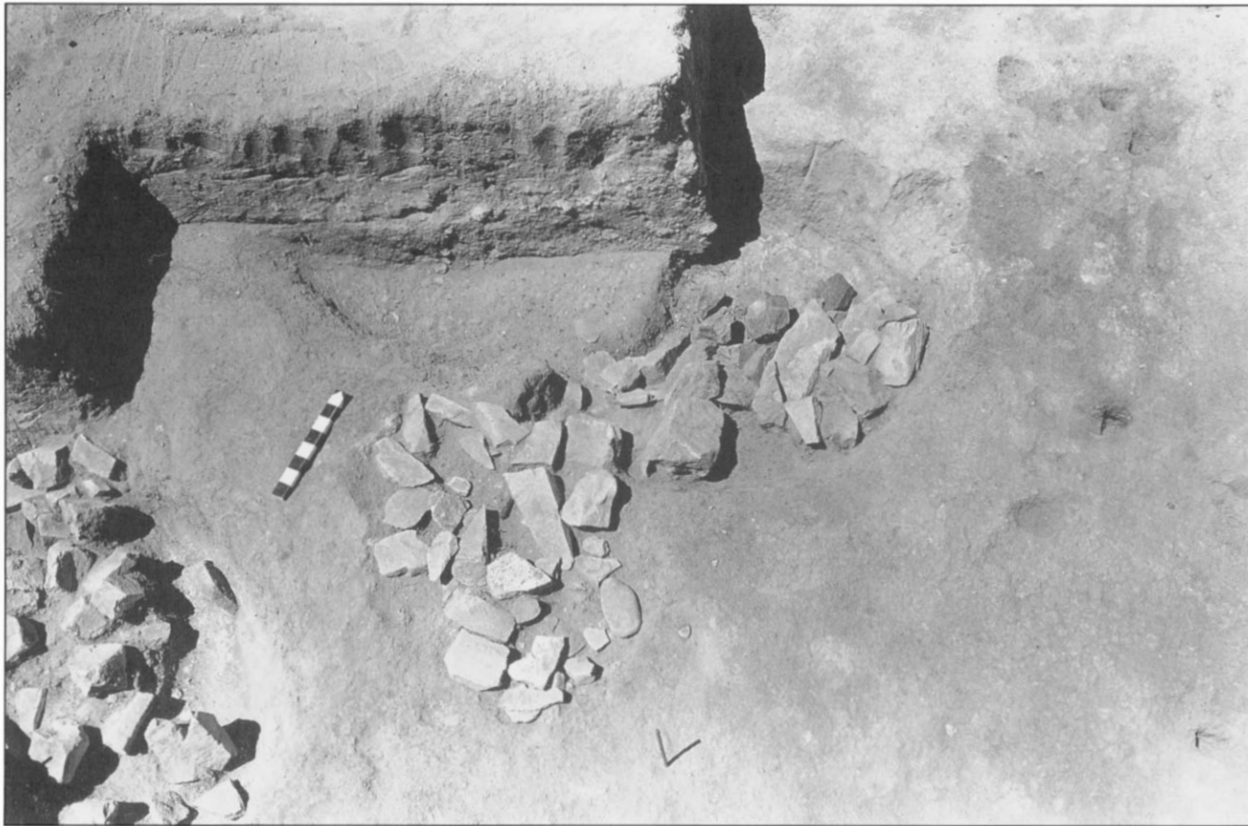
Figure 4.14. The pit and stones mark the location of feature H in plaza A, a possible oven. The pit contained stratified ash, charcoal, and burned rock and may have had a vent to the surface. Burned wood in the pit was dated at A.D. 1329. Scale is 40 cm in 5 cm increments. (Photo AH4-MM3-32).
