The Architecture
of Arroyo Hondo Pueblo,
New Mexico

WINIFRED CREAMER

ARROYO HONDO ARCHAEOLOGICAL SERIES, VOLUME 7

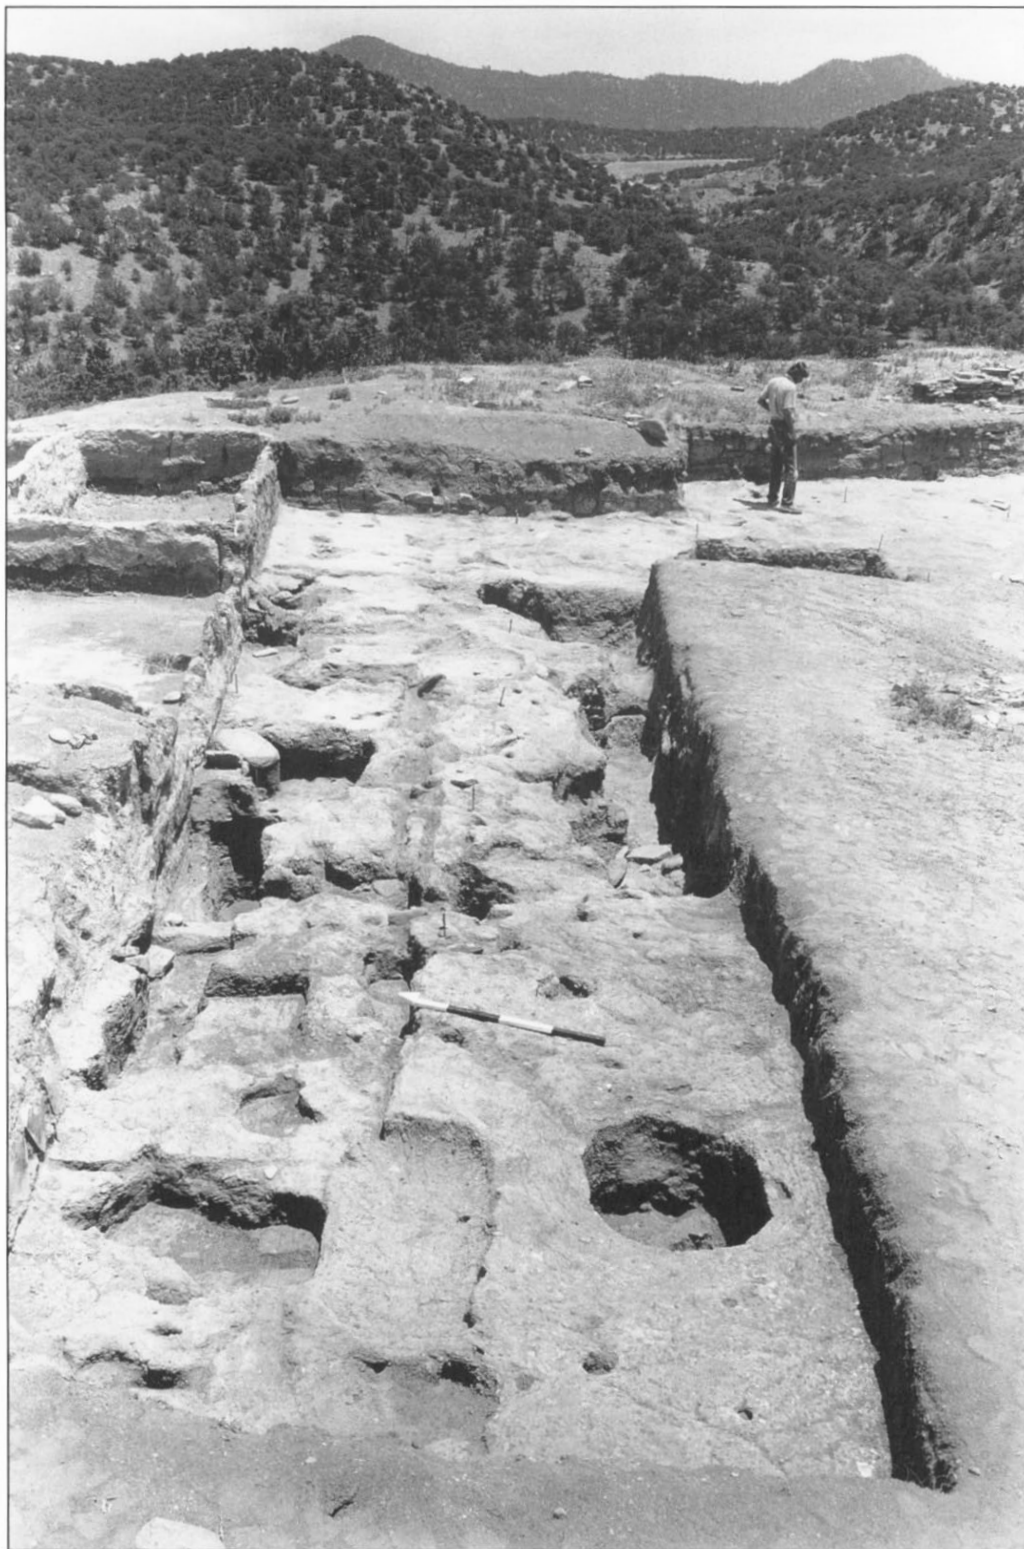
Figure 4.18. Overview of north side of plaza C, looking east, showing numerous excavated features. Plaza C was the only excavated plaza dating to Component II, and it exhibited the same diversity of domestic features found in Component I plazas. Scale is 1 m in 25 cm increments. (Photo AH4-DGN32-15).

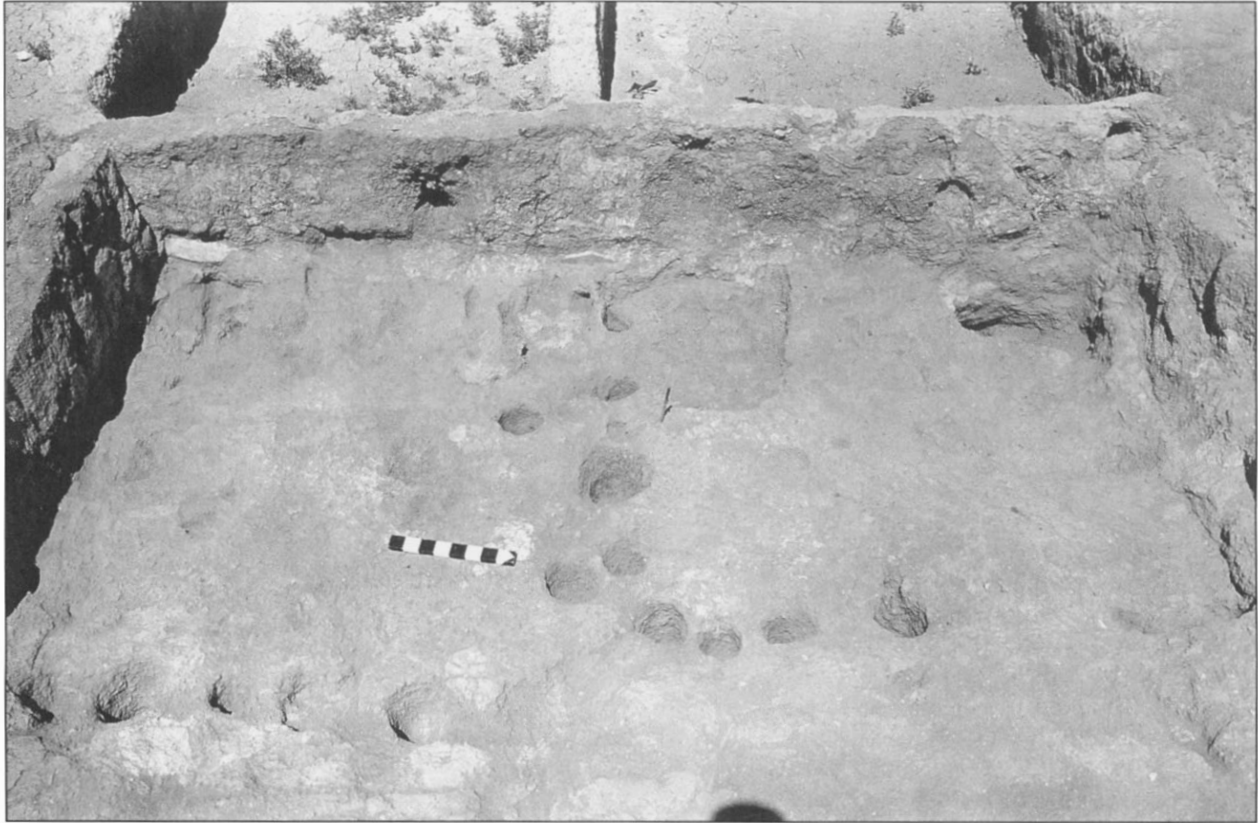
Figure 4.19. Overview of “post enclosure” complex in plaza C, indicated by the pattern of post holes. The enclosures were apparently built of closely spaced poles but were not covered with adobe, as in jacal construction. Mealing areas were found in each enclosure. Roomblock 9 is in the background. Scale is 40 cm in 5 cm increments. (Photo AH4-RWL1-22).

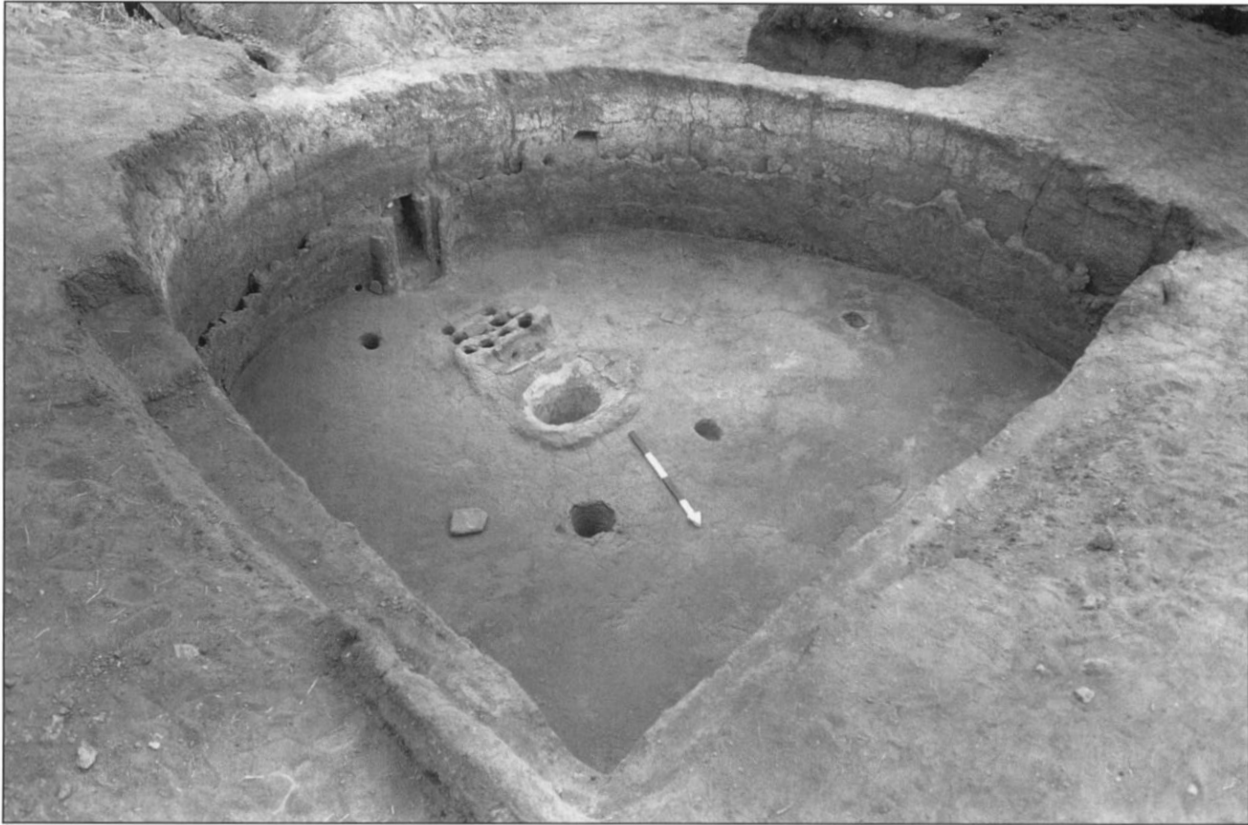
Figure 5.4. Overview, kiva 14-6. Unlike the other kivas at Arroyo Hondo, kiva 14-6 was above-ground, D-shaped, and built into the corner of roomblock 14. The firepit, ashpit, deflector, and ventilator are visible; beyond the deflector, two small holes define the ladder landing area. The small opening in the wall just left of the ventilator is the paho hole. Scale is 1 m in 25 cm increments. (Photo AH4-MPM6-28).

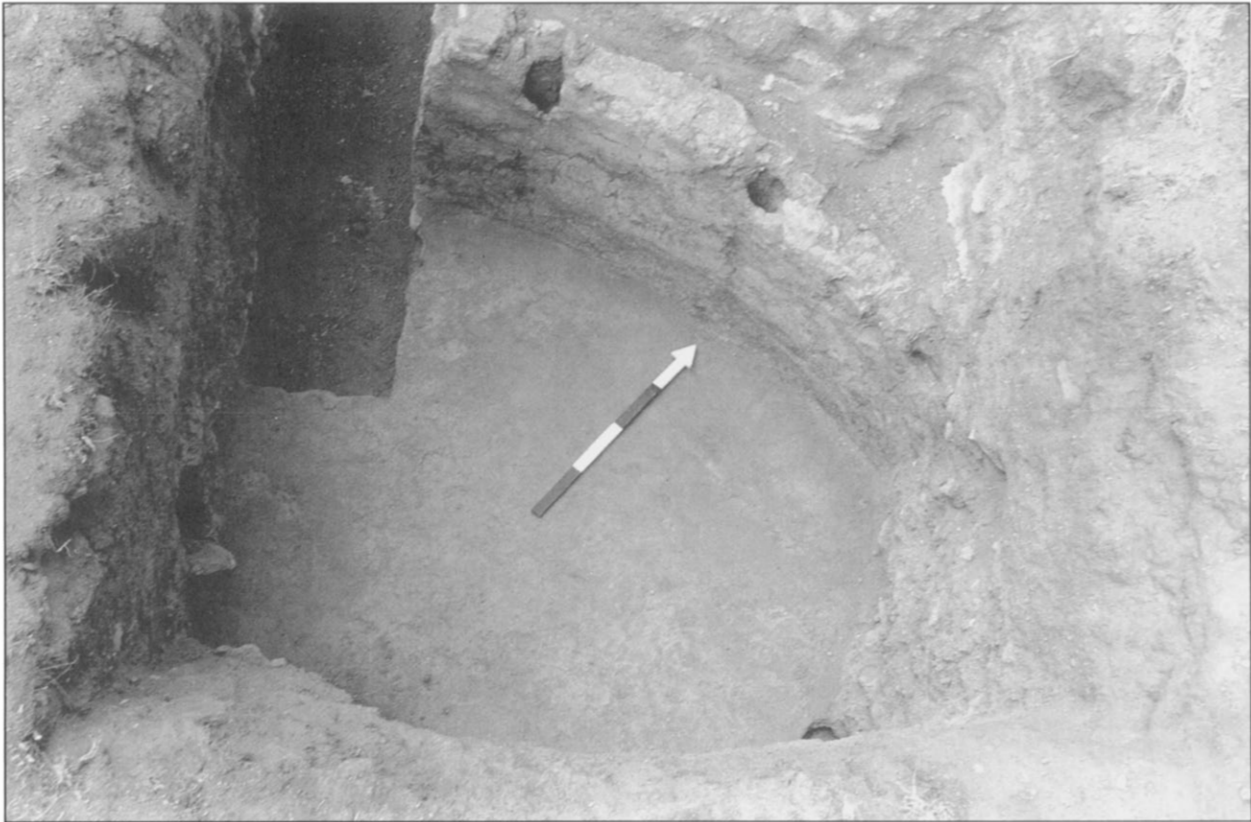
Figure 5.6. Overview, kiva D-2. Only one-fourth of this kiva was excavated. Excavations revealed no floor features, although post holes used in wall construction are visible at the top of the photo. Scale is 1 m in 25 cm increments. (Photo AH4-DGN49-28).

Five Component I kivas and one Component II kiva were excavated by Schwartz. Component I kivas G-5 (figs. 5.1, 5.2) and 14-6 (figs. 5.3, 5.4) and Component II kiva C-2 were completely excavated. Kivas D-2 (figs. 5.5, 5.6) and D-3 (figs. 5.7, 5.8) were partially excavated (4.5 m² and 11.5 m², respectively). The largest, kiva J (figs. 5.9, 5.10), originally excavated by Nelson in 1915, was completely reexcavated. The Component I kivas ranged from an estimated 4.4 to 10.5 m in diameter, and the single Component II kiva measured 7.5 m across (table 5.1; appendix C). All but one were round, subterranean, and located in plaza areas. Kiva 14-6 was D-shaped and constructed above-ground in the corner of a roomblock adjacent to plaza G. Kiva J was located at the far edge of open plaza J, away from the roomblocks.

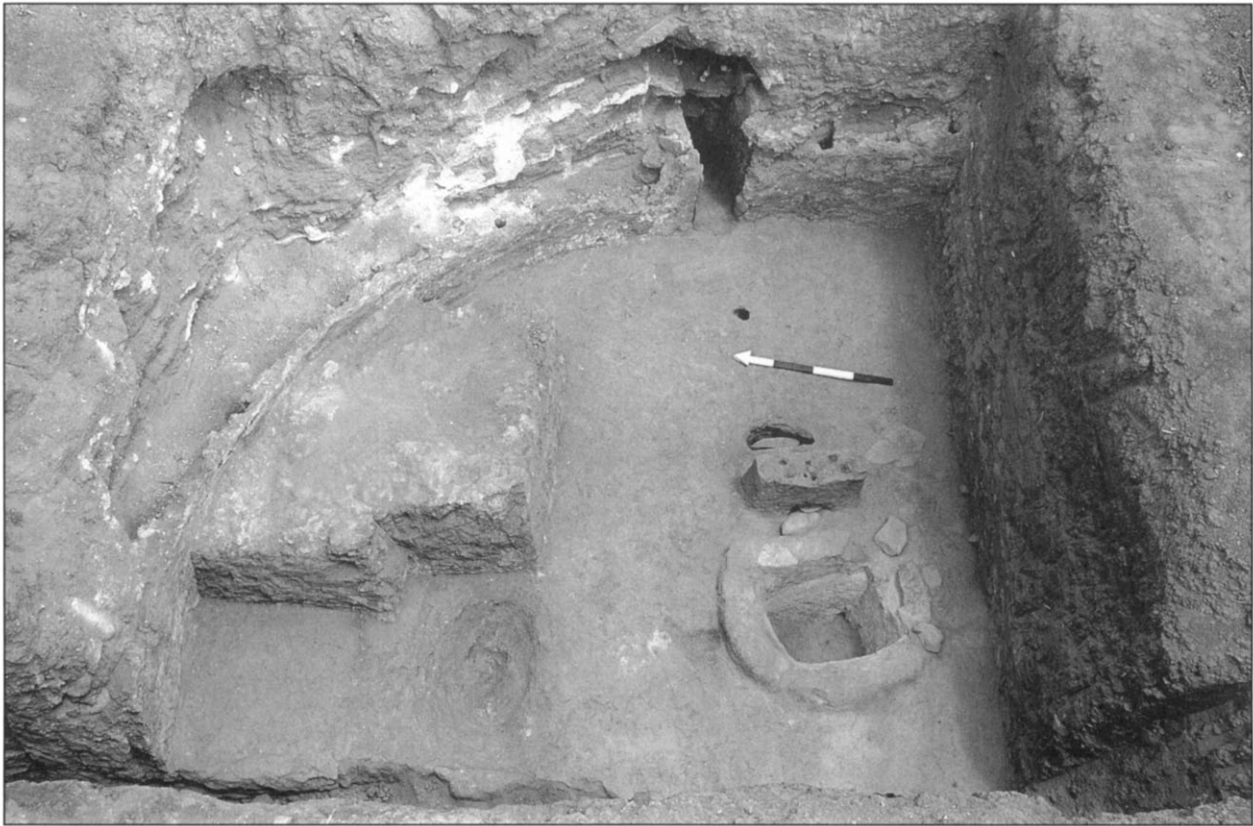
Figure 5.8. Overview, kiva D-3. Only one-fourth of this kiva was excavated after it was found in a plaza test trench. Excavations revealed a firepit, deflector, and several other features. Scale is 1 m in 25 cm increments. (Photo AH4-RWL3-28).

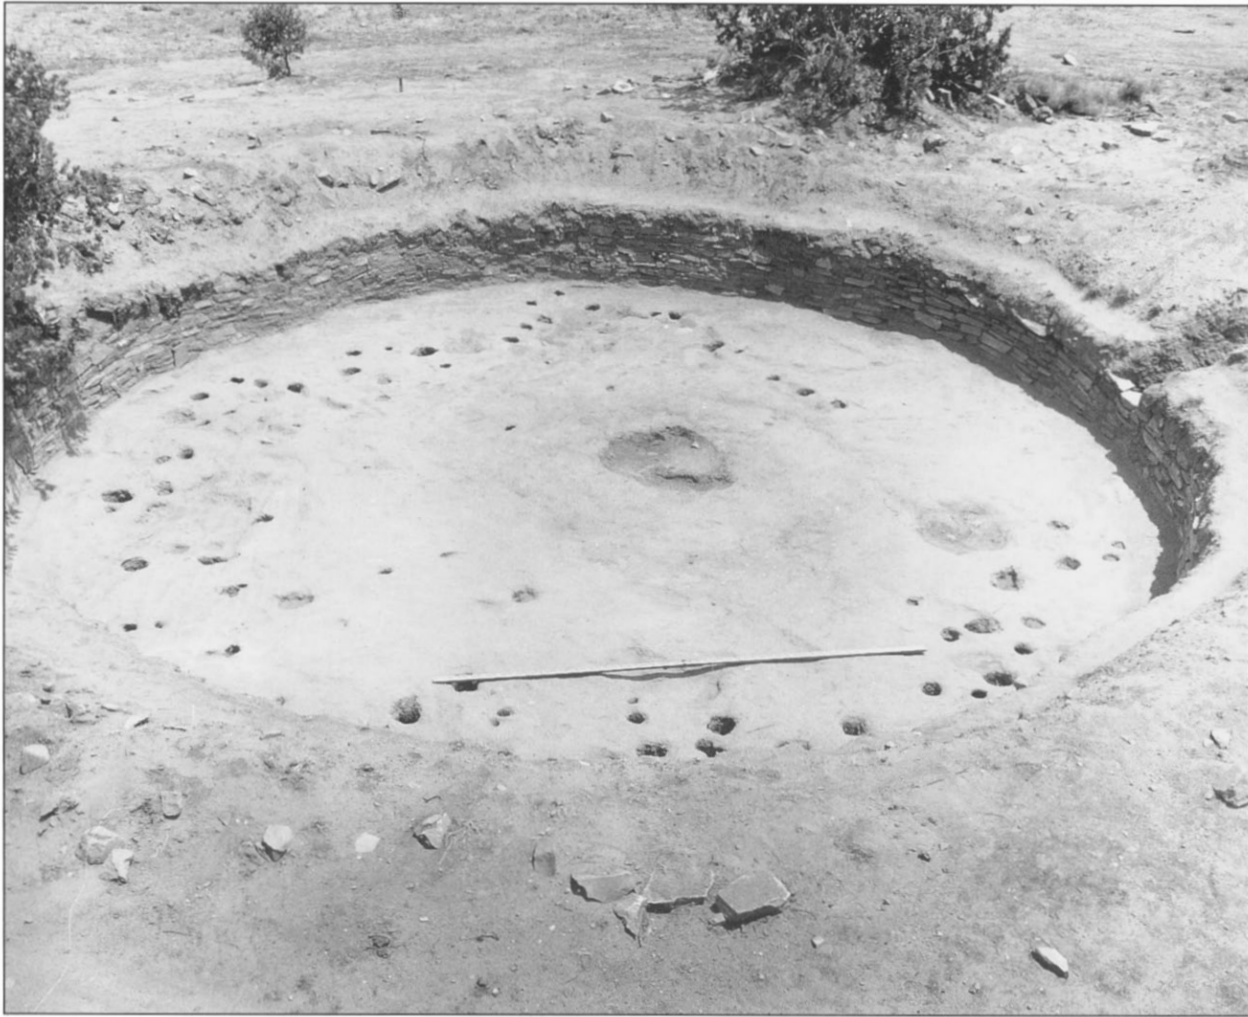
Figure 5.10. Overview, kiva J. Kiva J was the largest kiva at Arroyo Hondo and the only one that was not located in an enclosed plaza. It is at the lower end of the size range for great kivas. (Photo AH1-AS36-2).

Although Component I kivas were similar in construction techniques, they varied in size (table 5.1) and possibly in function. Kiva J, with a diameter of 10.5 m, falls in the lower range of size for "great kivas," as defined by Vivian and Reiter (1965:84). Great kivas were used as community structures throughout the Anasazi region beginning in the Basketmaker period. Kiva D-3, at 9.2 m in diameter, is also large and may have had some communitywide functions. Kivas G-5, 14-6, and D-2 were much smaller. Ellis (1950:287) has distinguished "big" and "little" kivas among modern Pueblo groups. She suggests that big kivas, found in villages singly or in pairs, were community structures used for affairs in which the whole village participated. Little kivas were the locations for retreats or ceremonies by kiva societies,

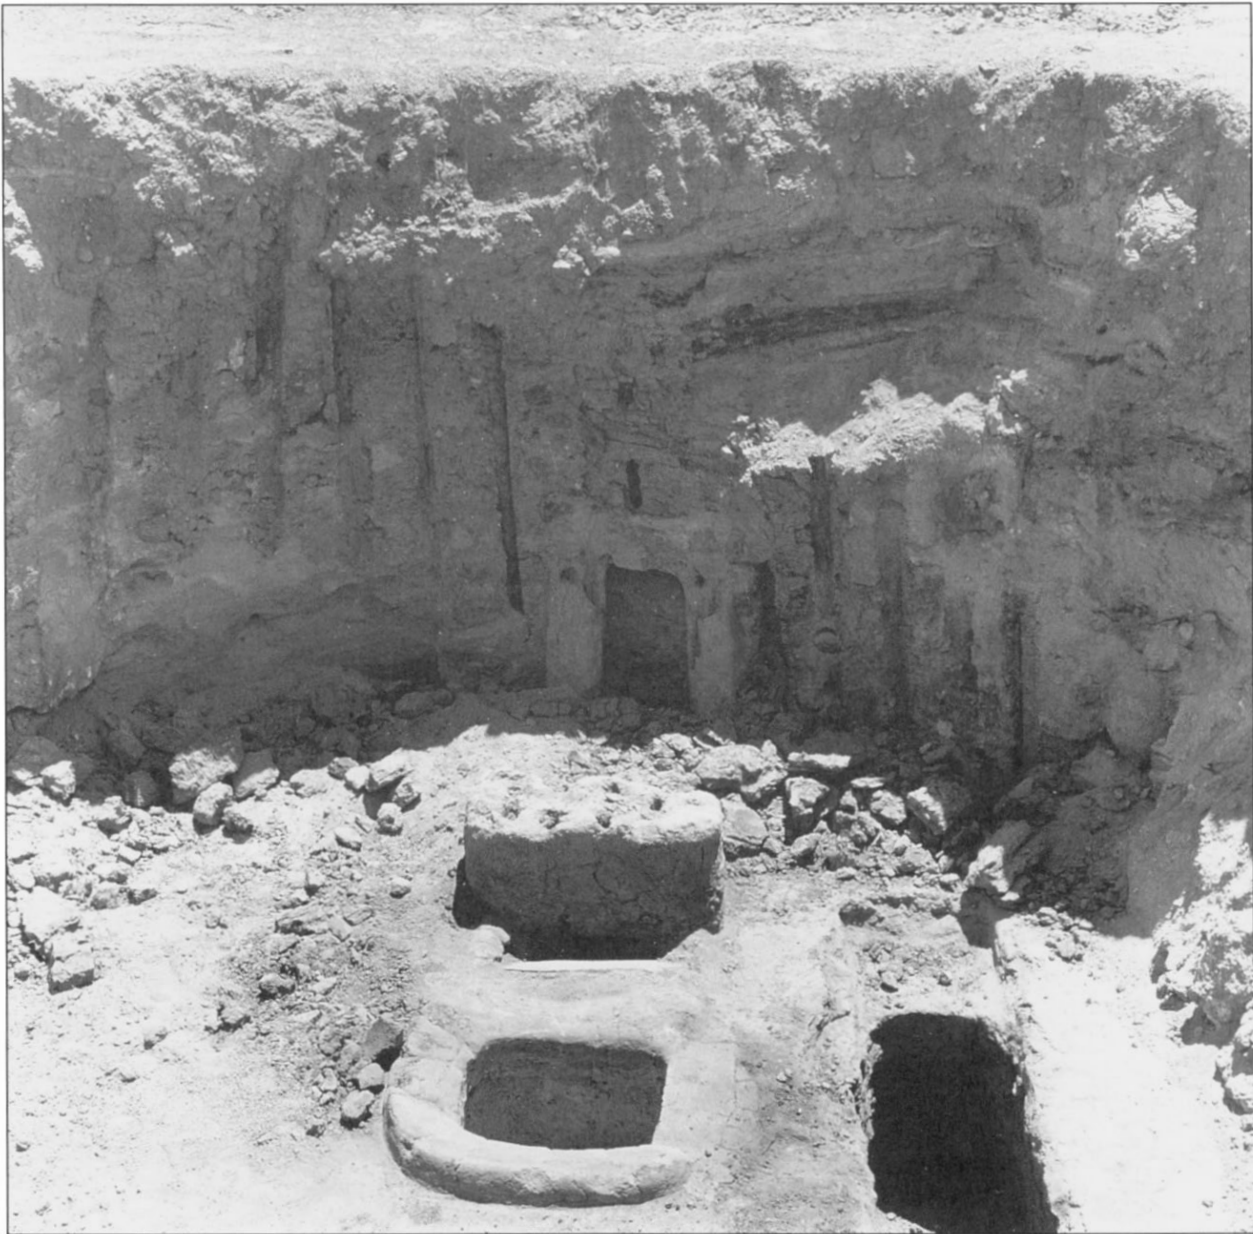
Figure 5.11. Kiva G-5, showing the impressions of posts and planks that were placed around the edge of the kiva pit and then covered with adobe and plaster to form interior walls. The possible foot drum is visible on the right, at the bottom of the photograph. (Photo AH4-DGN43-5 or AH4-DGN46-36).

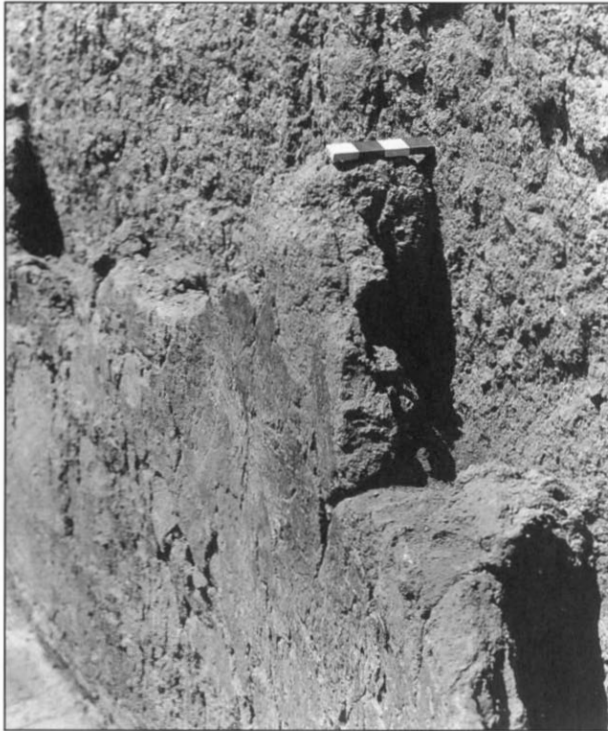
Figure 5.12. Kiva 14-6, showing layers of adobe and plaster that covered posts and planks set around the edge of the kiva pit.

Component I kivas were constructed using similar techniques. First, a large pit, 1 to 2 m deep, was excavated (table 5.1). Posts and planks were set around the edge of the pit to form walls, and these were covered with adobe (fig. 5.11). Adobe over plank wall construction of this type was identified only in kivas at Arroyo Hondo. The walls were then plastered with a mixture of white ash or gypsum and water, or with fine micaceous clay (fig. 5.12). The number of plaster layers varied; walls were apparently replastered when it became necessary to make repairs or for artistic or ceremonial reasons. Three kivas (D-2, D-3, and 14-6) had painted or colored plaster forming a border between the lower and upper sections of the walls. Design motifs extended horizontally along the wall, sometimes punctuated by pendant dots or figures. The dominant colors, red and yellow (probably from hematite and limonite), were painted over white or gray plaster.

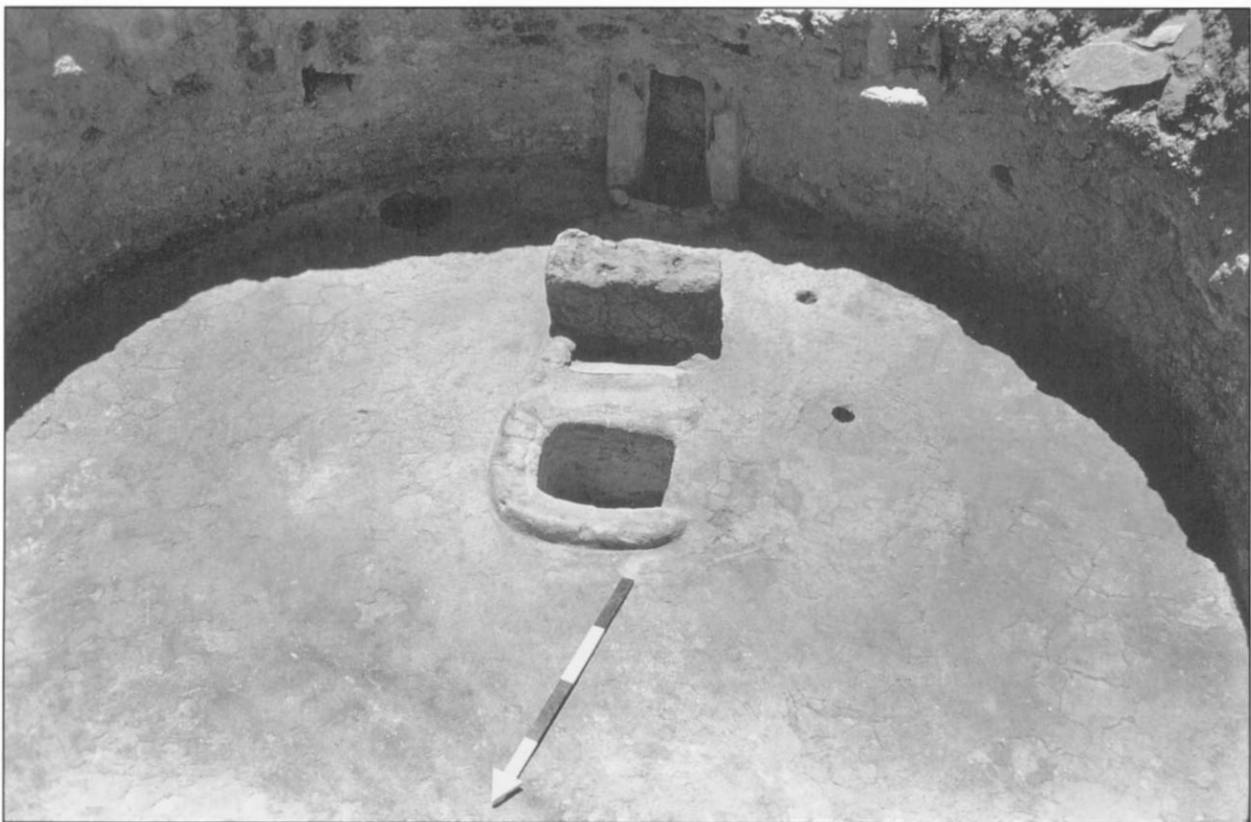
Figure 5.13. Kiva G-5, showing the relationship of the firepit, ashpit, deflector, and ventilator. Wall niches can be seen on either side of the ventilator. Scale is 1 m in 25 cm increments. (Photo AH4-JDB5-16).

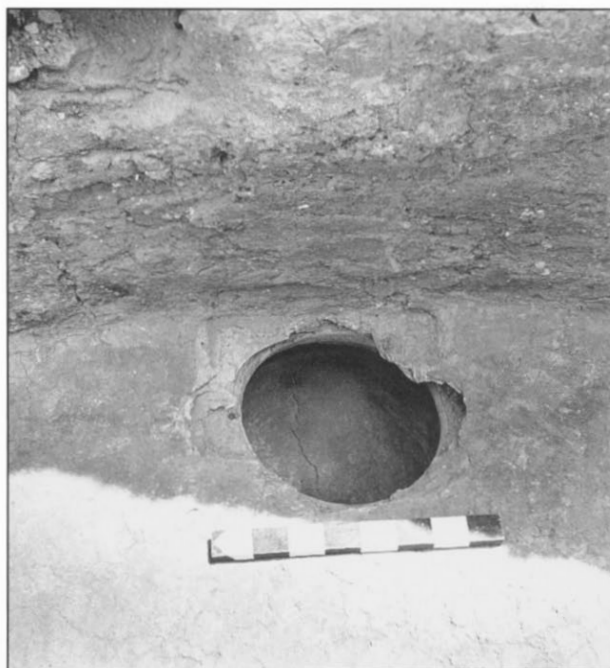
Figure 5.15. Vessel in cist built into the floor of kiva G-5. It had been filled with sand and covered with a large culinary sherd. Scale is 40 cm in 5 cm increments. (Photo AH4-JDB6-27).

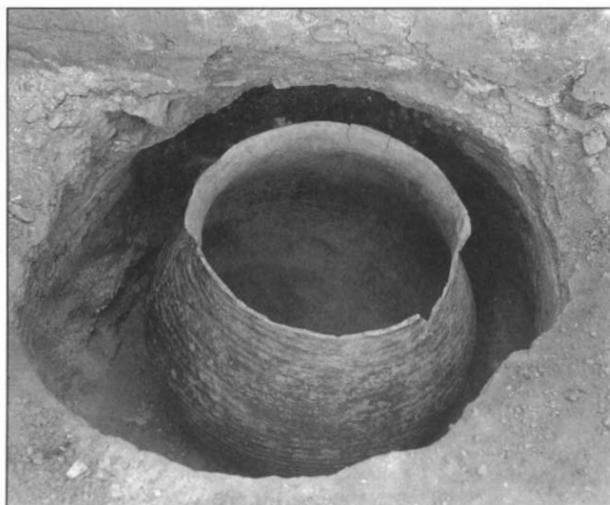
Figure 5.16. Pot placed in cist in the floor of kiva 14-6. It had been filled with clean, coarse sand and sealed with a wooden lintel. Pots in subfloor cists at Arroyo Hondo were found only in kivas. (Photo AH4-DGN46-32).

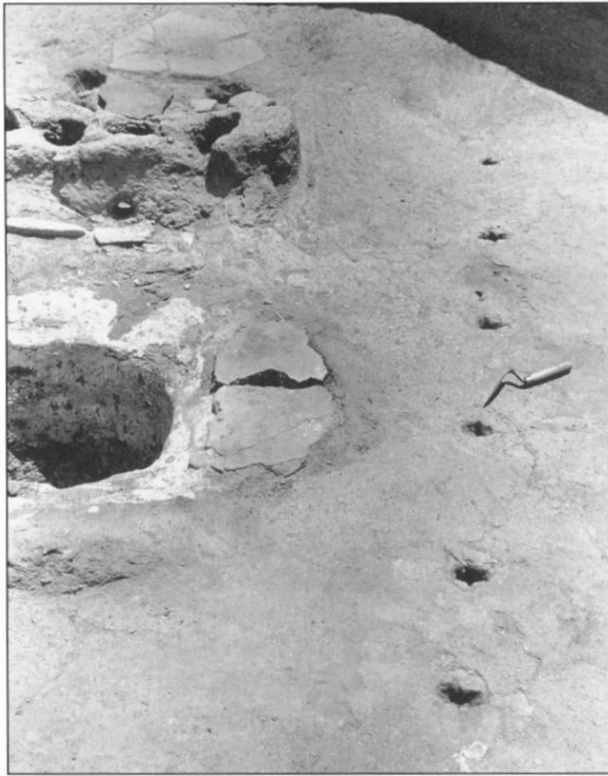
Figure 5.17. The trowel marks the center of six loom holes located west of the firepit complex in kiva 14-6. In modern pueblos, weaving, when performed in kivas, is a men's activity. The pit in the foreground is a post hole. (Photo AH4-MPM7-13).

Kivas built during Component I exhibited numerous floor holes (table 5.1). These features may have served as seats for roof-support posts or entry ladders. In kivas G-5 and 14-6, small cylindrical holes sealed with plaster were located in line with the hearth and ventilator complexes. The cavities were filled with fine pumice sand. Kiva D-3 had an empty hole in a similar location. These features may have been *sipapus* (small holes in the floor of modern Pueblo kivas representing the place of emergence from the underworld; Cordell 1984:73). Both historically and prehistorically, the sipapu has been recorded in corresponding positions. Small holes between the ventilator mouth and the ladder landing area, which showed heavy wear around the opening, may have been seats for beam ladders. In kivas G-5 and 14-6, vessels were found sunk into the floor and filled with sand (figs. 5.15, 5.16). A similar feature in Component II kiva C was positioned like a sipapu. The subfloor vessel in kiva G-5 was covered with large culinary sherds, whereas the one in kiva 14-6 was covered with a wooden lintel. In kiva 14-6, a series of loom holes was located west of the firepit complex (fig. 5.17).

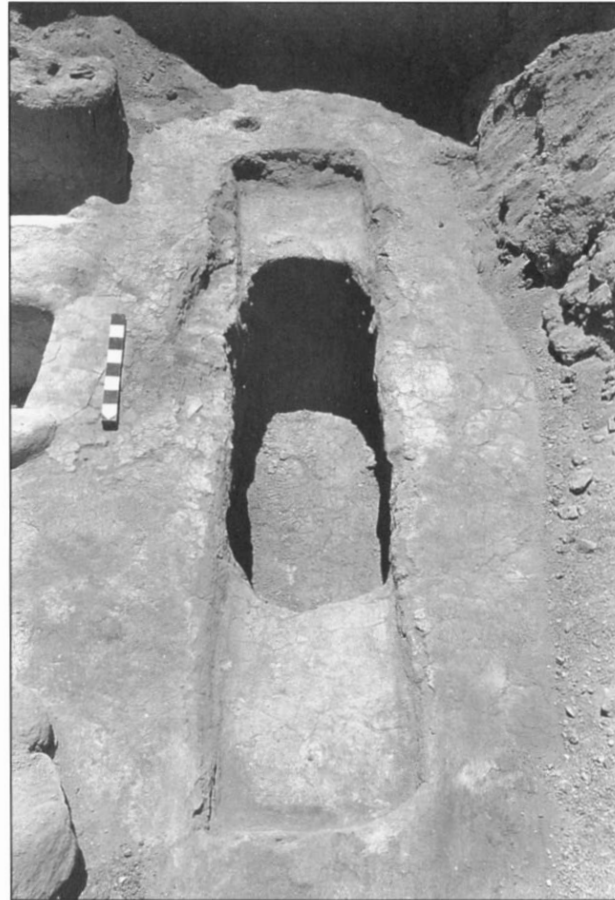
Figure 5.18. This vault beneath the floor of kiva G-5 may have been a foot drum. It had been filled with stones and was located just west of the firepit complex. Scale is 40 cm in 5 cm increments. (Photo AH4-JDB7-29).

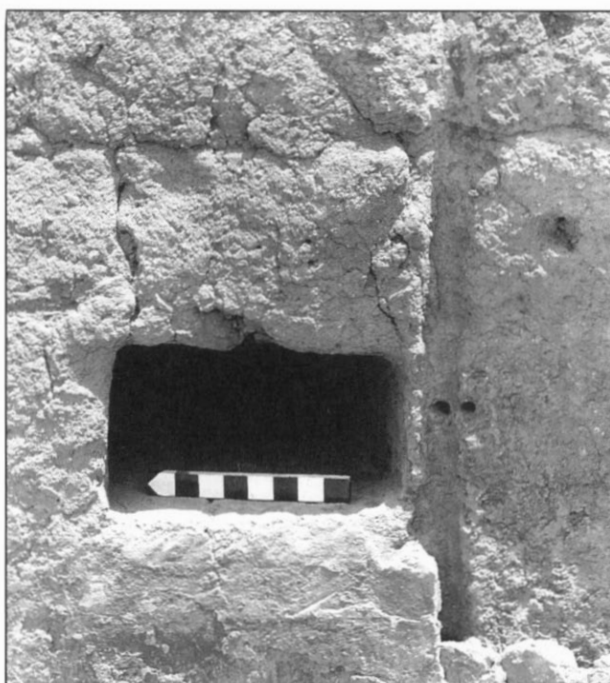
Figure 5.19. This large, rectangular niche was located in the east wall of kiva 14-6. The interior of the niche is plastered, and it extends back to the interface with a parallel wall to the east. A vertical post mold, part of the wall of kiva 14-6, is visible to the right of the niche. Scale is 40 cm in 5 cm increments. (Photo AH4-MPM6-19).

Sealed wall niches were found in two kivas (14-6 and G-5; table 5.1). In kiva G-5, three of the four wall niches were located at the cardinal directions, and one was slightly offset. All were relatively small diameter, deep holes. In kiva 14-6, the five wall niches were variable in size, diameter, and location (figs. 5.19, 5.20).

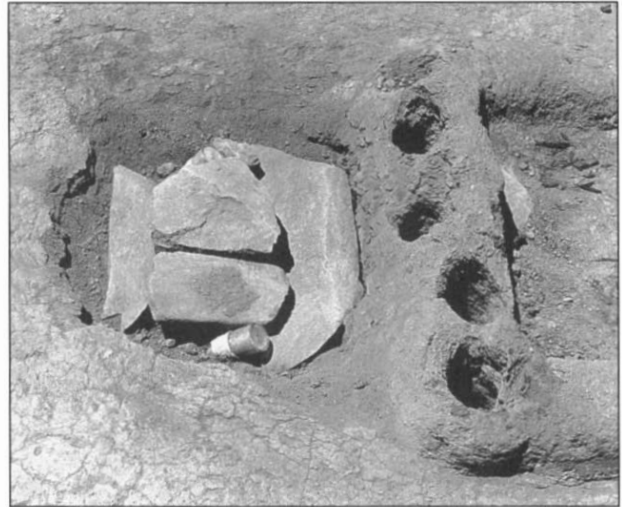
Figure 5.24. Stones in the center of the photo were part of the ladder landing area in kiva C-2 and were used to anchor ladder stringers. The metal canisters on either side of the stones mark the location of the ladder stringers. The four post holes at the right once formed the deflector at the end of the firepit complex. (Photo AH2-JDB13-29).

Inside the kiva, the firepit, ashpit, and deflector were encircled by a roughly rectangular clay ridge 9 cm high (table 5.1; fig. 5.23). The firepit was a rectangular box of stone slabs with a clay floor. The ashpit was a rectangular clay-lined feature with a small stone set in one corner. This feature was separated from the firepit by a ridge of clay. Five posts were set in the rim of the ashpit and functioned as a deflector. The posts, set in a line, were 8 to 10 cm apart; no chinking between posts was noted. The posts were probably no more than 35 cm high, or they would have hit the ladder. Fragments of both ladder stringers were found in place, anchored by stone slabs

(fig. 5.24). Six loom holes 25 cm apart were arranged in a line between the ventilator and the hearth.

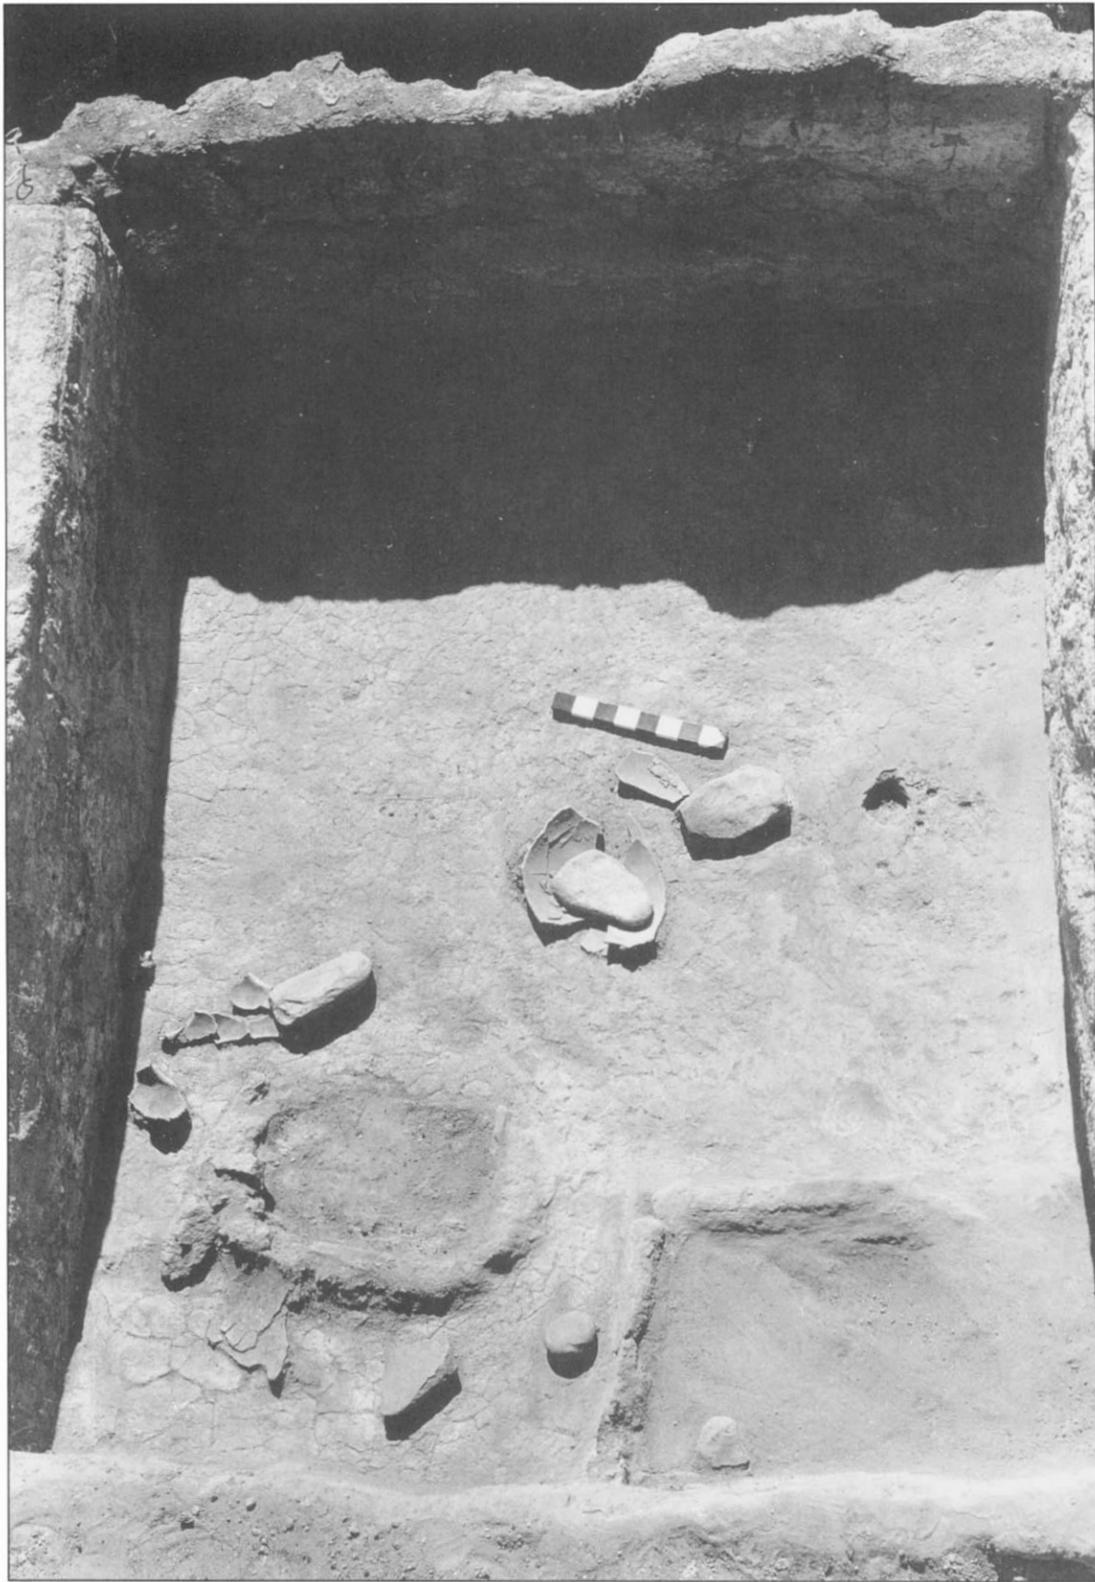
Figure 6.1. Room 9-10 was identified as a living room. A slab-lined hearth with a clay rim is in the left foreground, and a mealing bin defined by a clay rim is in the corner of the room, right foreground. A second slab-lined hearth was found on the roof. Broken pottery and ground-stone artifacts are visible on the floor. Scale is 40 cm in 5 cm increments. (Photo AH3-RW14-17).

Living rooms at pueblo sites have been identified as those rooms having a firepit or fire-blackening on the walls and ceiling, larger sizes, location in an upper story, and presence of niches, wall entries, shelves, meal bins, and pottery vessels (table 6.1; fig. 6.1). Each of these features implies storage or access and suggests activities associated with food preparation. The presence of a source of heat is widely assumed to indicate a room used for cooking, sleeping, and other group activities,
